# 2022 REGULAR INSPECTION REPORT

## SENECA LAKE DAM (NJDEP File No. 22-183)

Sparta Township  
Sussex County, New Jersey

**GZA GeoEnvironmental, Inc.**

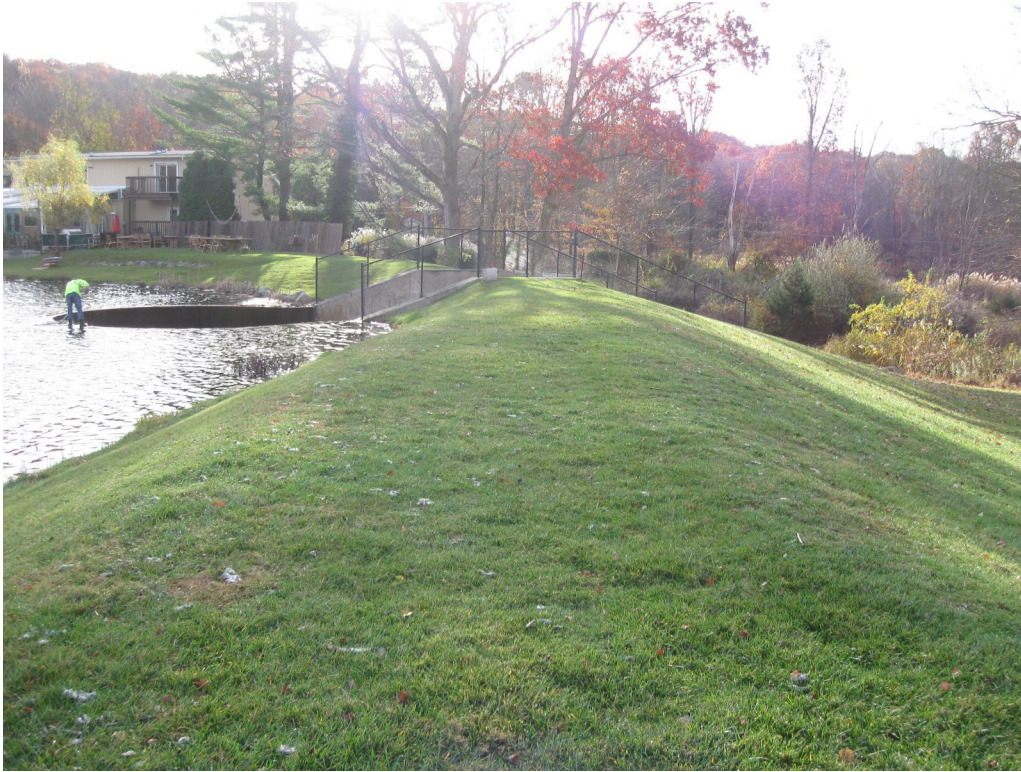
**Photo No. 1: Right side dam crest looking left toward the spillway.**

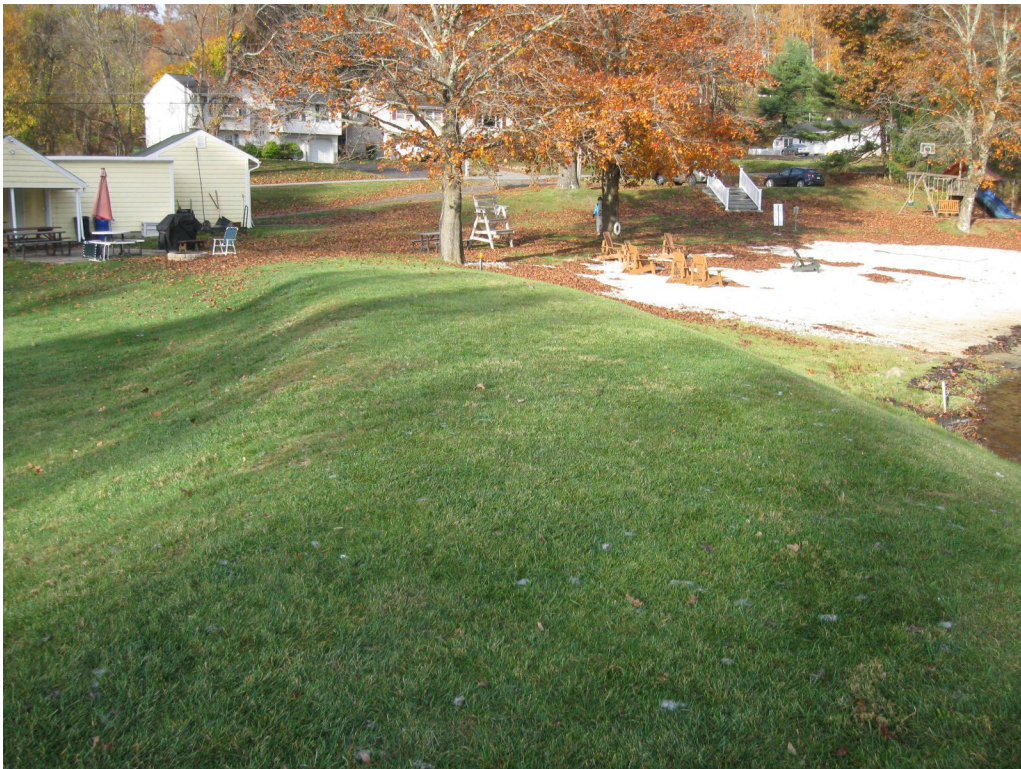
**Photo No. 2: Right side dam crest looking right toward the right abutment.**

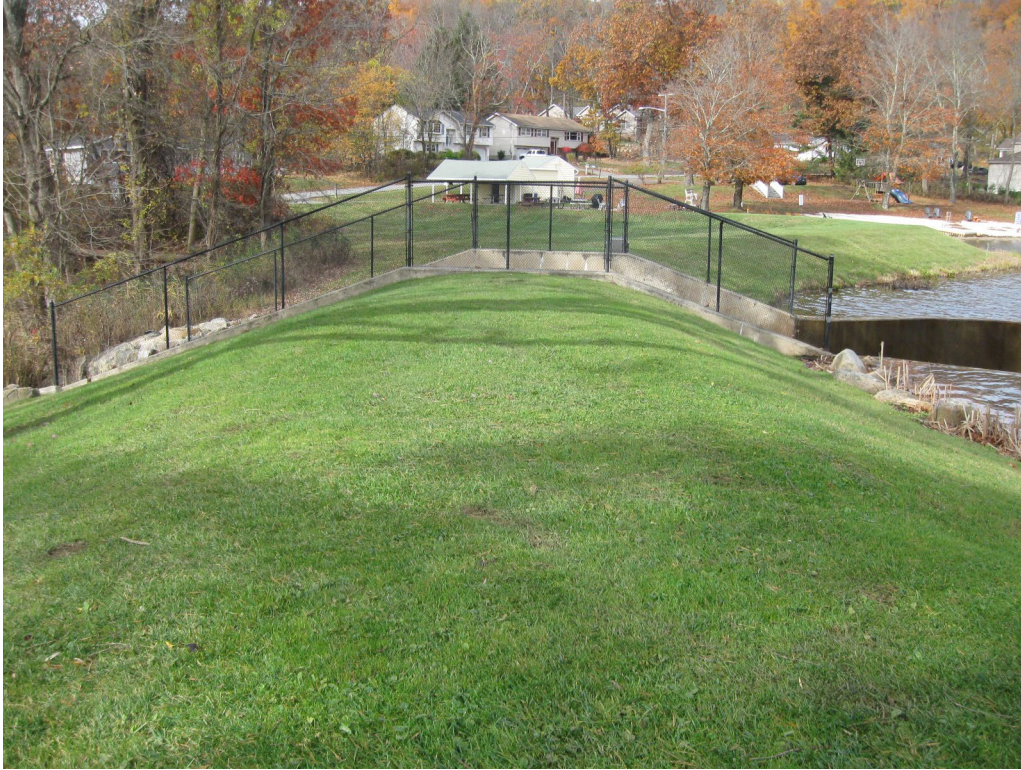
**Photo No. 3: Left side dam crest looking right toward the spillway.**

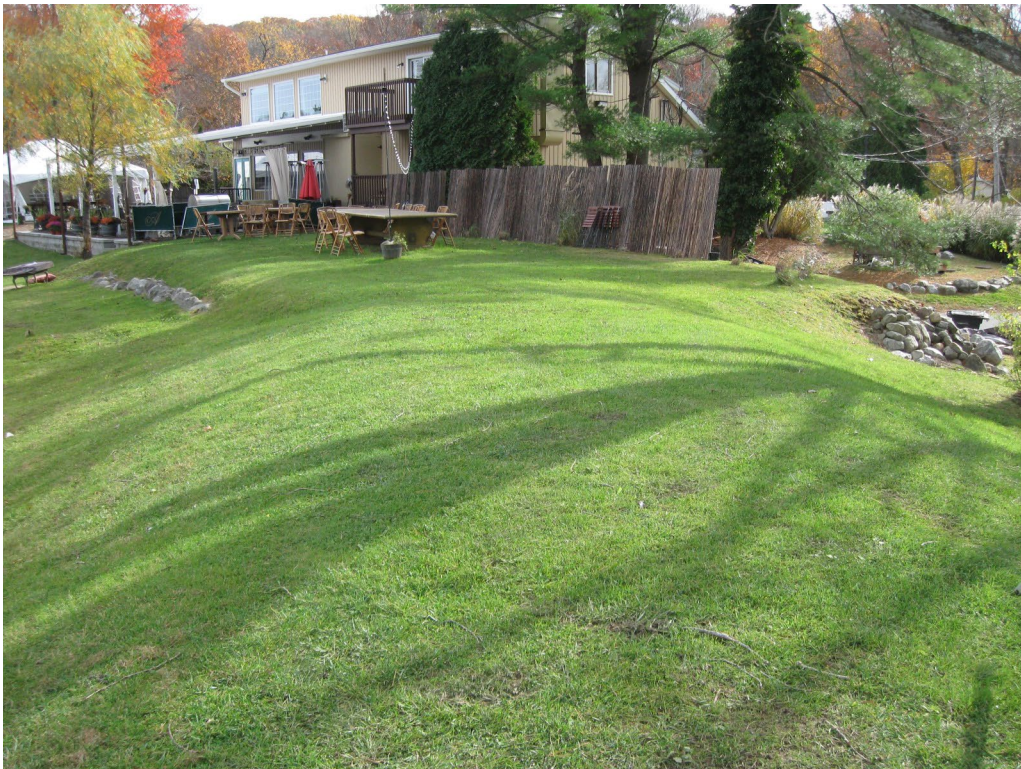
**Photo No. 4: Left side dam crest looking left toward the restaurant and dike.**

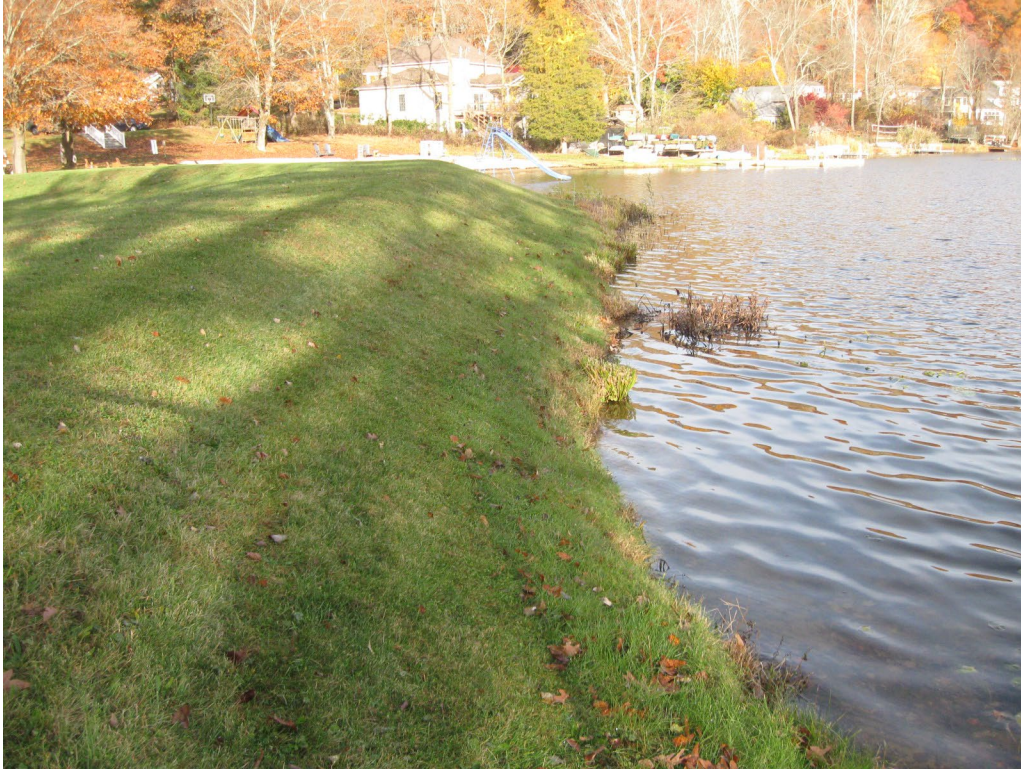
**Photo No. 5: Right side upstream slope of the dam  
looking right toward the bend.**

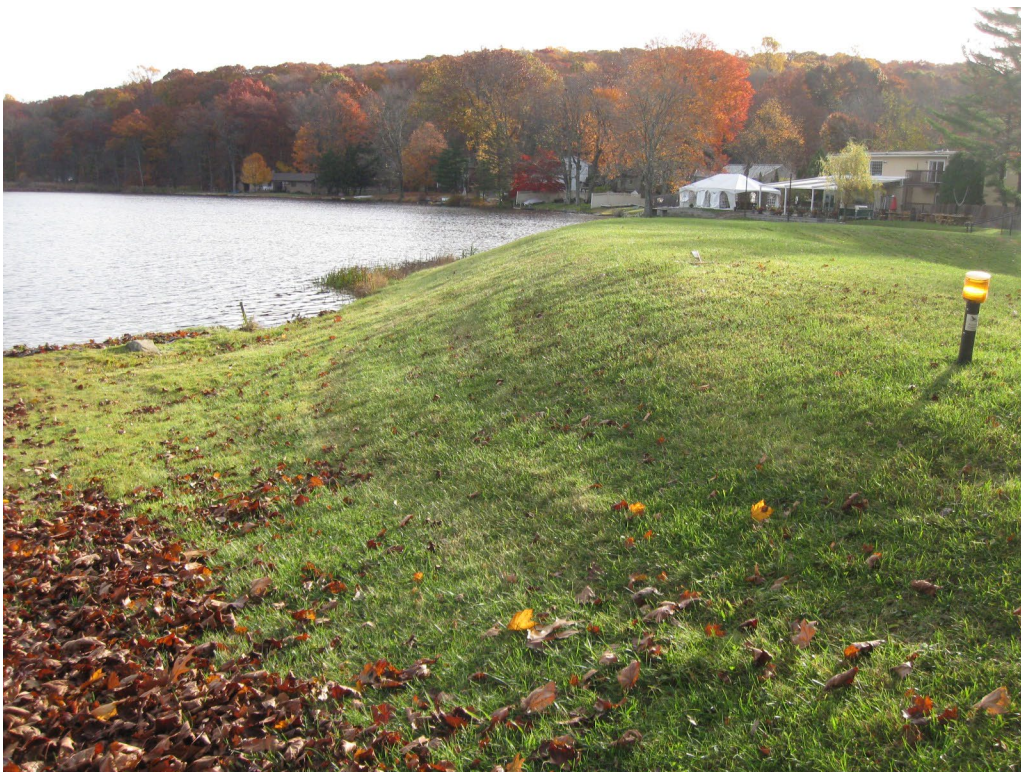
**Photo No. 6: Right side upstream slope of the dam  
looking left toward the bend.**

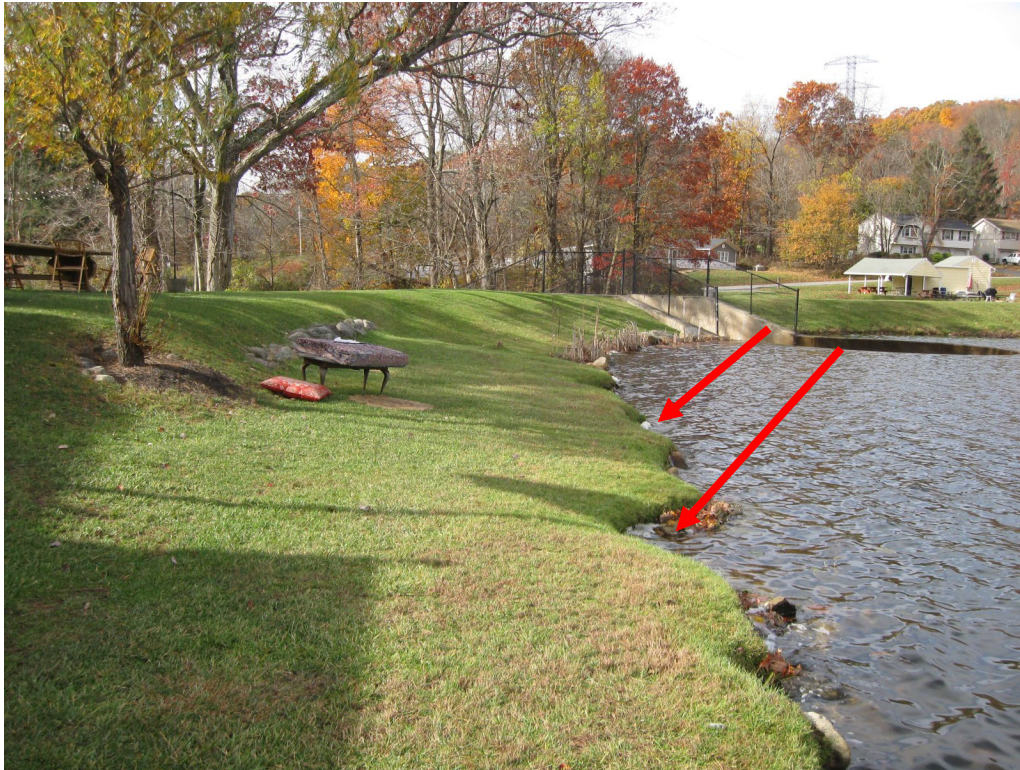
**Photo No. 7: Left side upstream slope of the dam looking right toward the spillway.  
Note the scarping along the lake edge at the bench.**

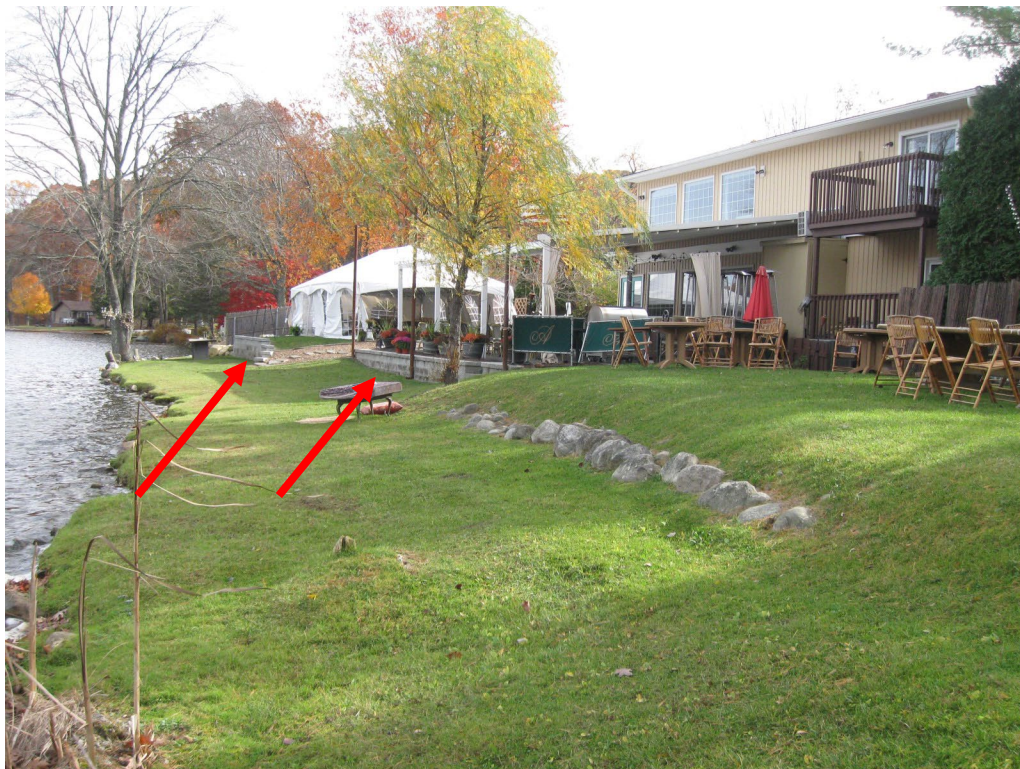
along the outdoor dining area just upstream of the restaurant between the 2016 and 2018 inspections. Prior to the 2020 inspection, an additional section of retaining wall was added to the left to expand the outdoor dining area. Based on a comparison with photos from 2020, no significant additional modifications were observed in the outdoor dining area during this inspection.

**Photo No. 8: Left side upstream slope of the dam looking left along the restaurant.  
Note the segmental block retaining walls.**

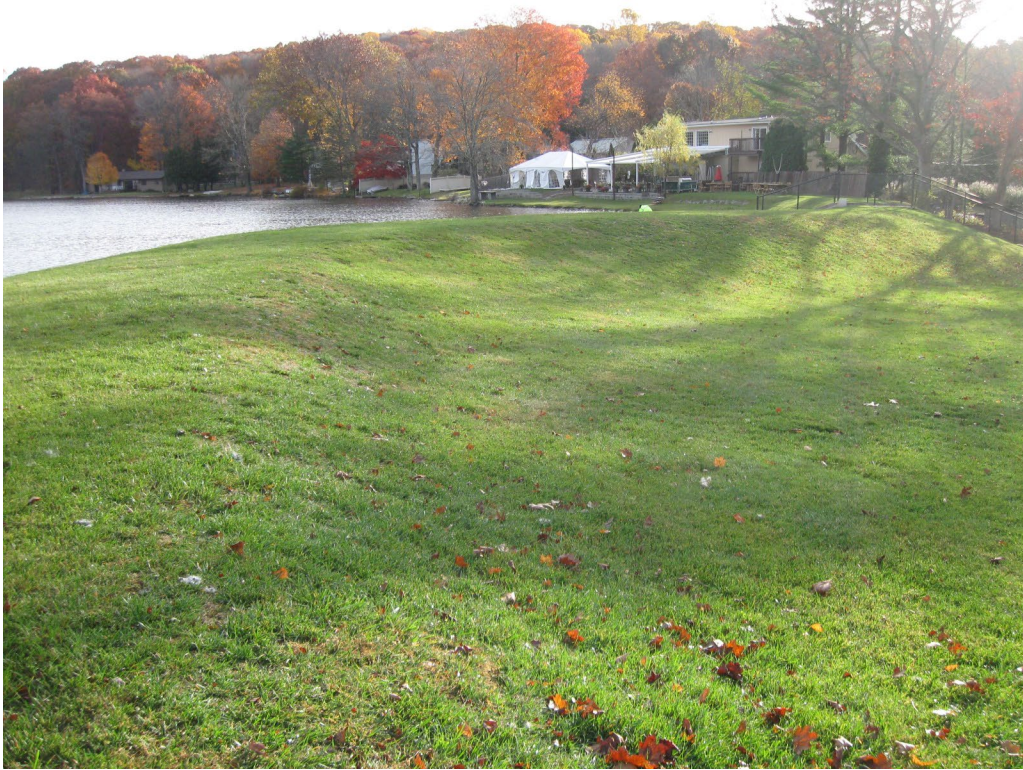
**Photo No. 9: Right side downstream slope and toe of the dam looking left toward the spillway.**

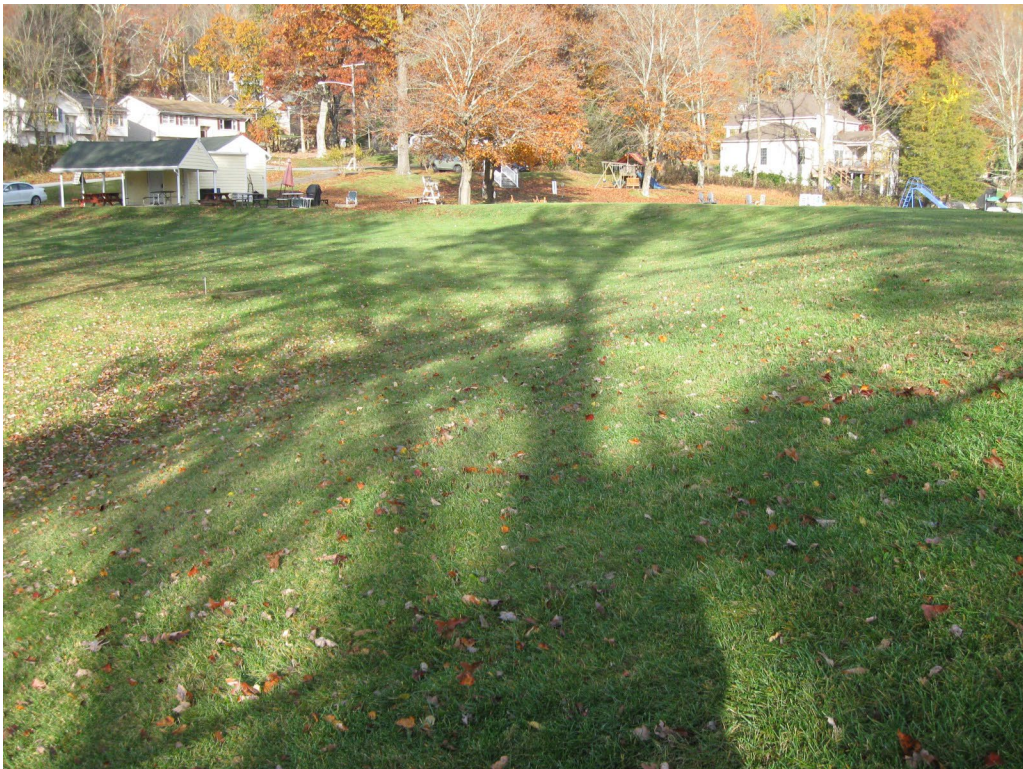
**Photo No. 10: Right side downstream slope and toe of the dam looking right toward the right abutment.**

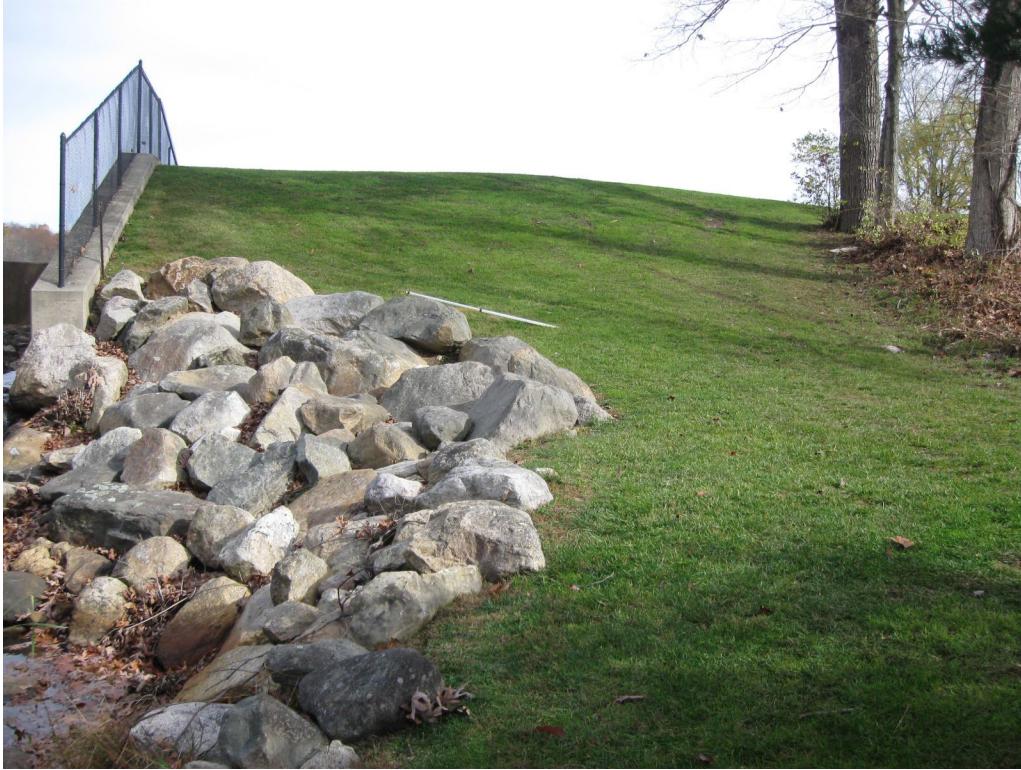
**Photo No. 11: Left side downstream slope of the dam looking upstream from the toe.**

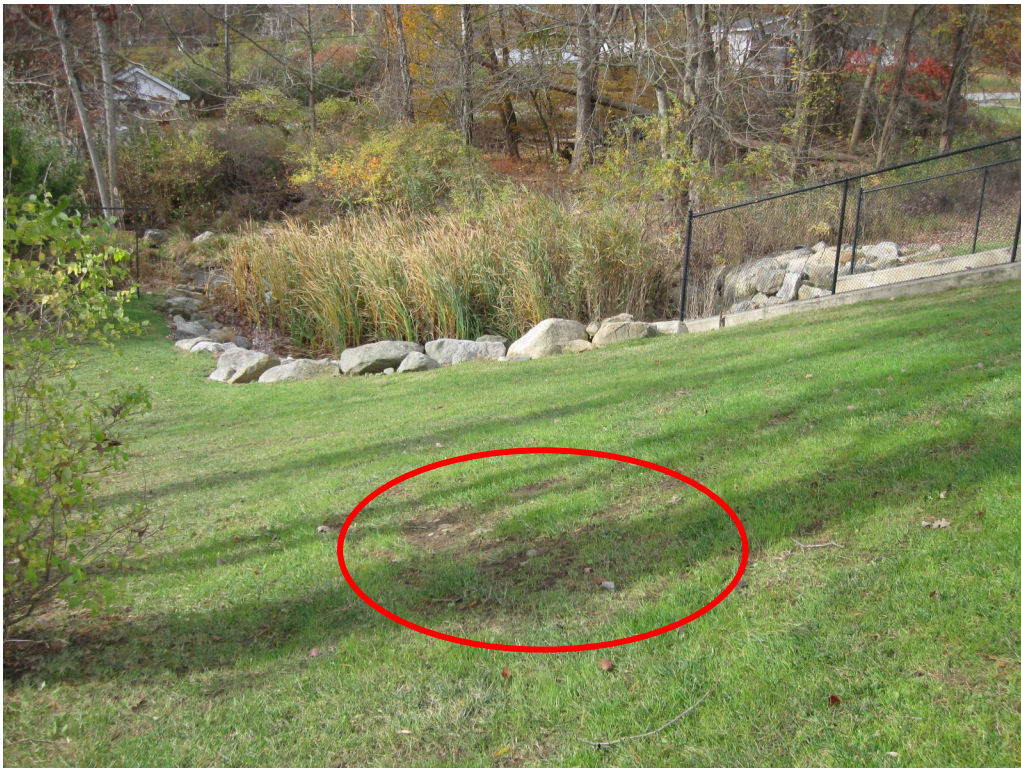
<b>Unusual Conditions:</b>	<p>There was filter fabric exposed at the bottom of the slope beneath the riprap at the contact with the spillway training walls on both sides. Riprap may have become displaced in these locations. This condition was observed during previous inspections and no significant change was apparent during this inspection.</p> <p>Some smaller stones in the rock rubble wall near the restaurant were displaced mid-slope. This condition was observed during the 2018 and 2020 inspections. Some additional stones appeared to be displaced from the wall since the 2020 inspection.</p> <p>A localized area of sparse grass cover was observed on the downstream slope immediately left of the spillway.</p>

**Photo No. 12: Left side downstream slope of the dam looking right toward the spillway. Note the area of sparse grass cover.**

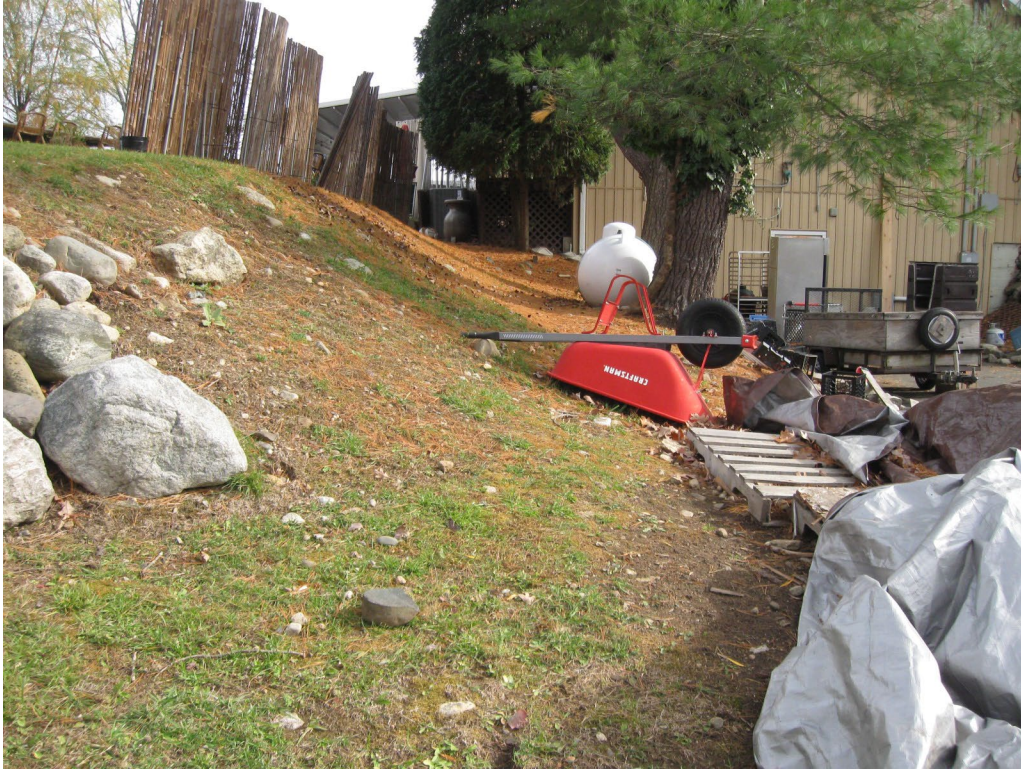
**Photo No. 13: Left side downstream slope of the dam looking left toward the restaurant.**

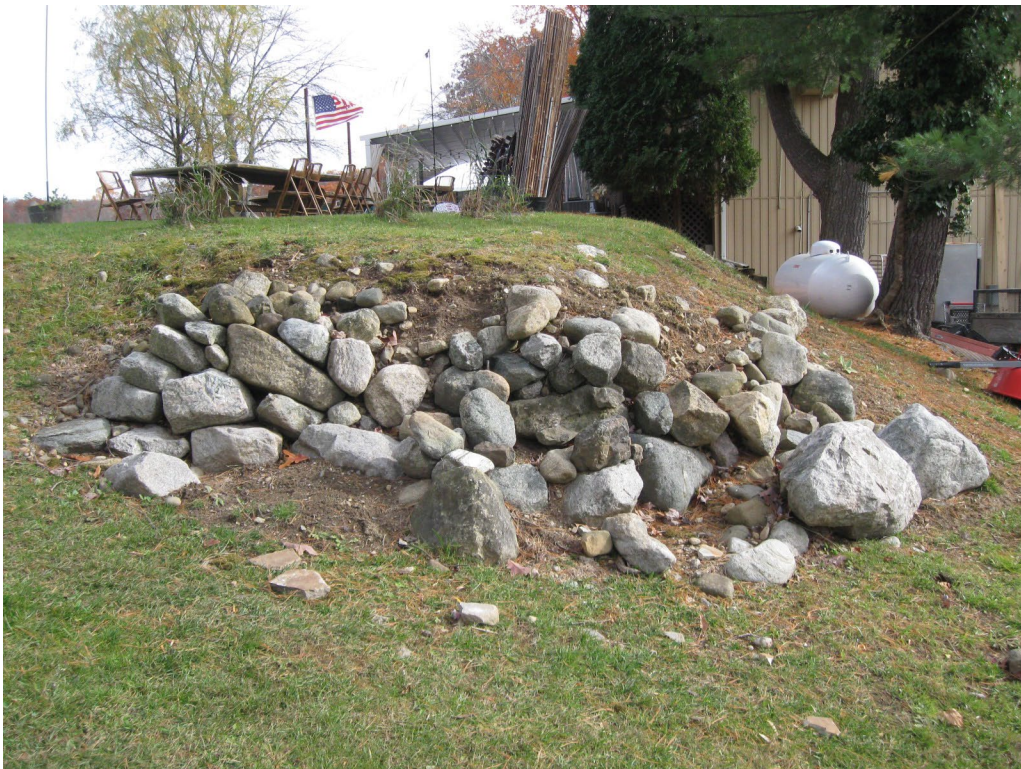
**Photo No. 14: Closeup of the rock rubble wall on the left side downstream slope of the dam looking left toward the restaurant.**

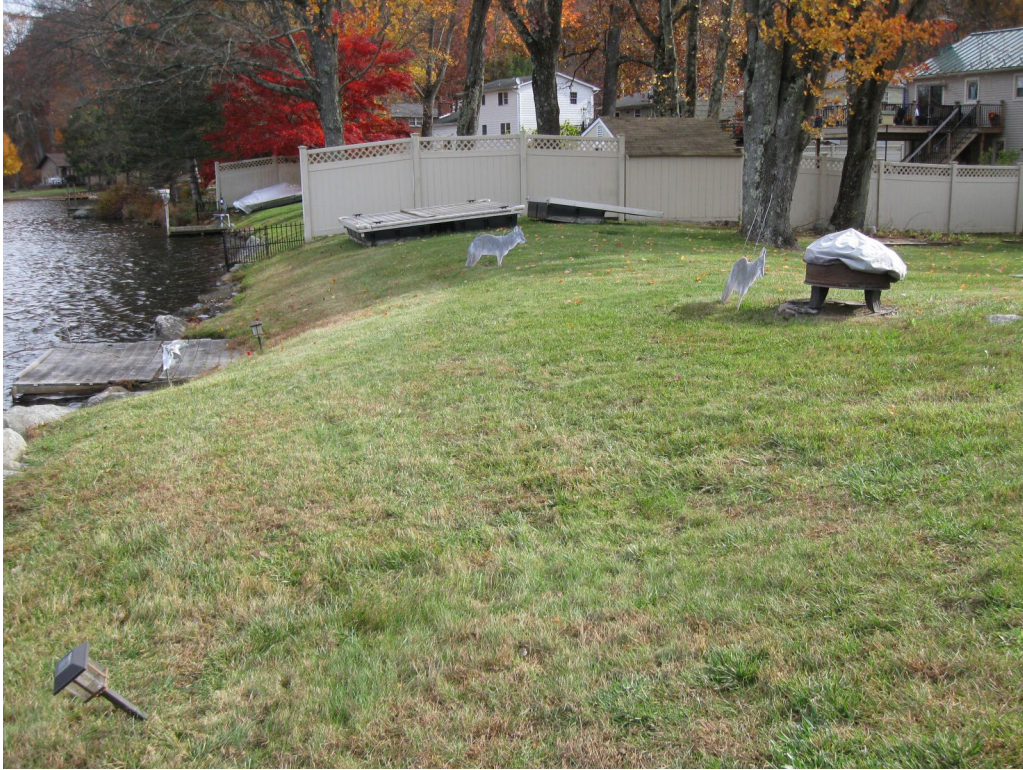
**Photo No. 15: Dike on Lot 113 looking left.**

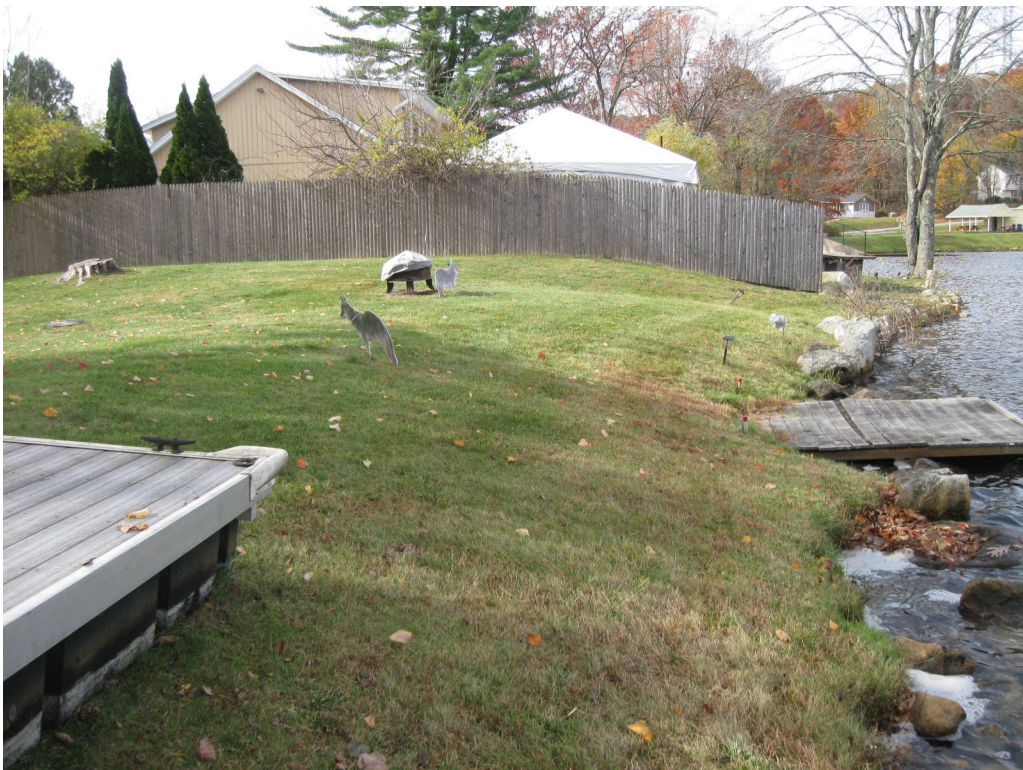
**Photo No. 16: Dike on Lot 112 looking right toward the restaurant.**

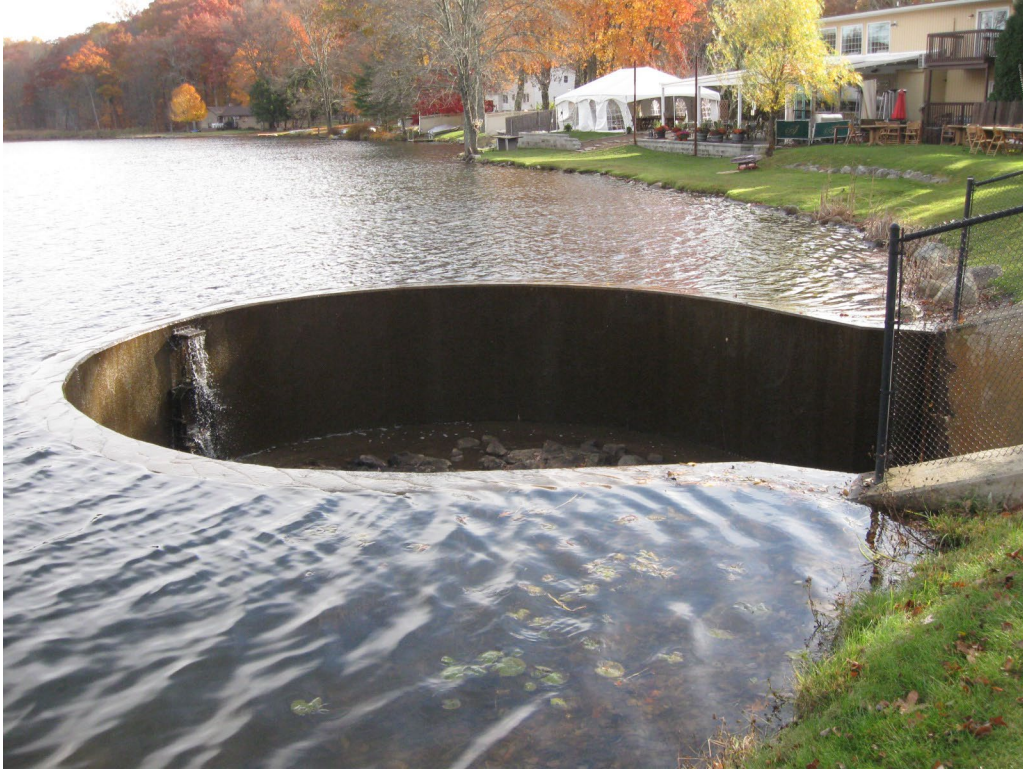
**Photo No. 17: Spillway entrance and crest looking left.**

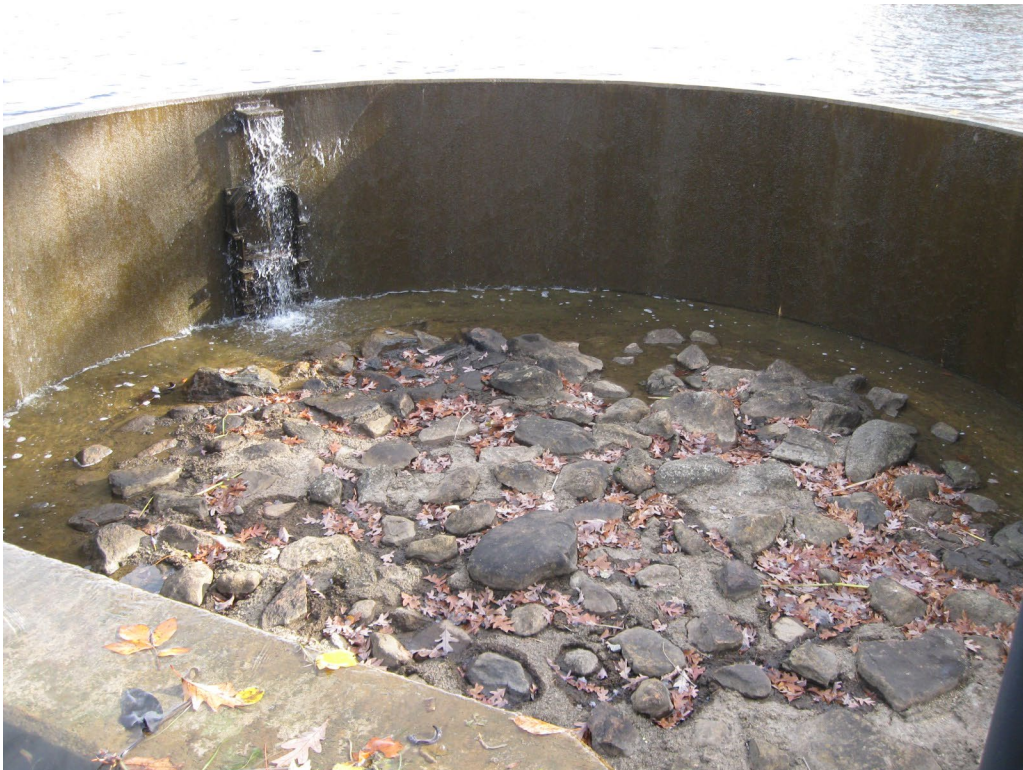
**Condition of Material:** Concrete appeared intact and in generally good condition. No significant cracks or spalls were observed on the crest or downstream face of the spillway. Efflorescence was observed along the base of the downstream face of the spillway. Conditions appeared similar to the 2020 inspection.

**Photo No. 18: Downstream face of spillway looking left.**

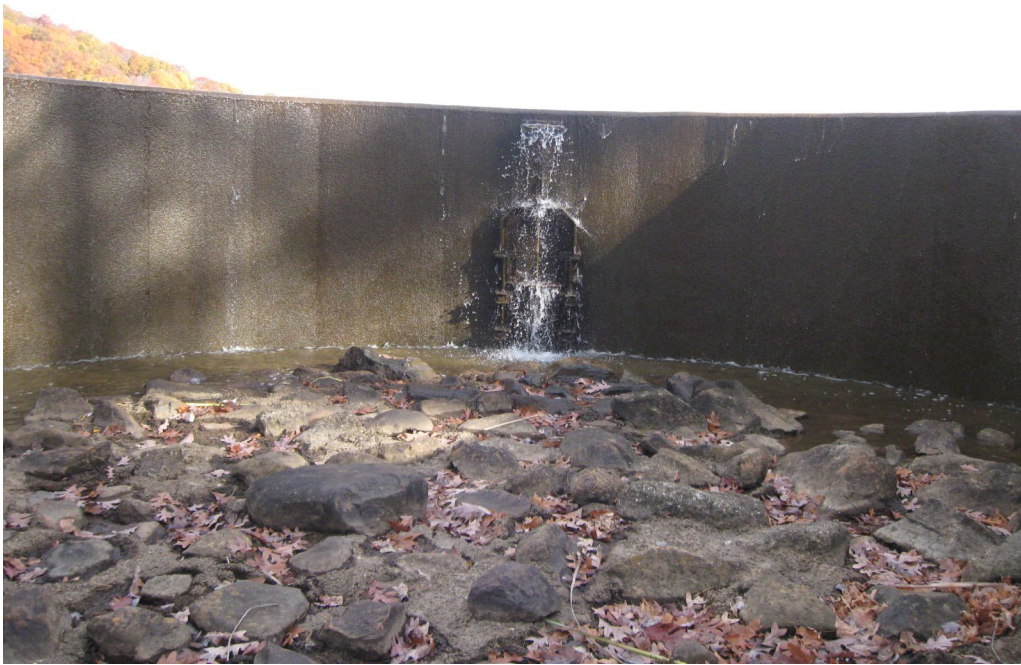
**Photo No. 19: Downstream face of spillway looking upstream.**

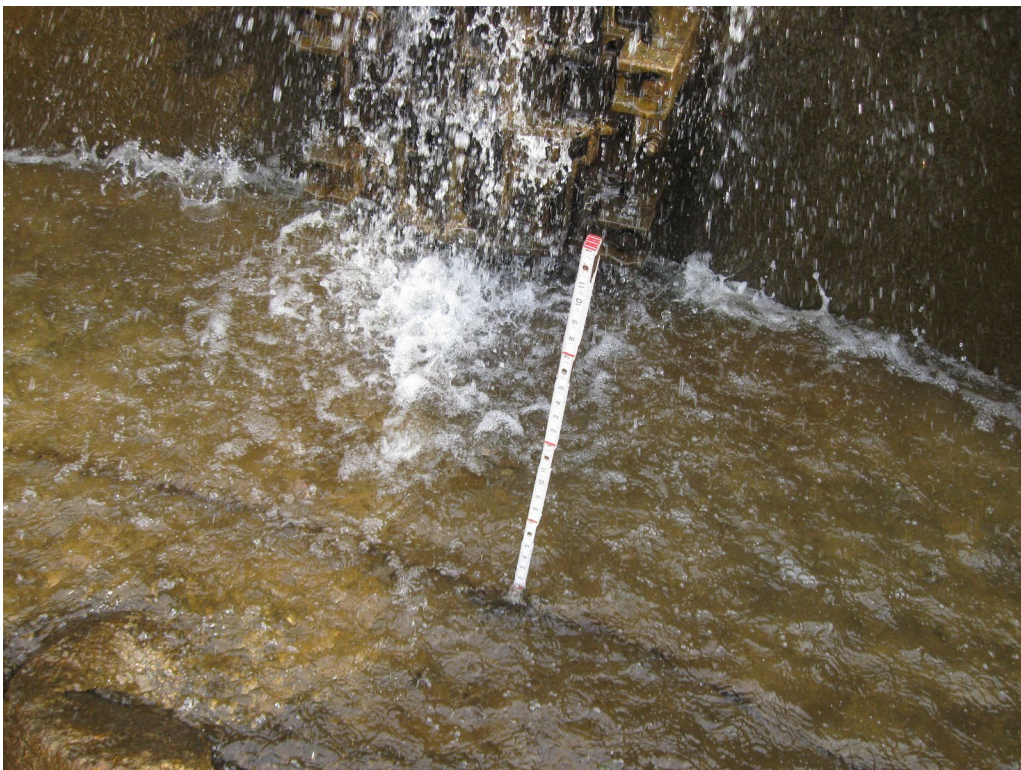
The contact between the spillway downstream face and concrete footing appeared intact. Some minor voids were observed between the concrete footing and grouted riprap. Voids were mainly located in the center of the spillway between the right and left joints. One void measured 8 inches deep near the left joint and another void measured 12 inches deep near the low level outlet. Voids were difficult to observe due to flow conditions.

**Photo No. 20: Closeup of a typical void between the spillway footing and the grouted riprap apron.**

1. **Continue to visually monitor cracks in the concrete spillway training walls.**
2. **Fill the minor voids between the spillway concrete footing and the grouted riprap apron.**

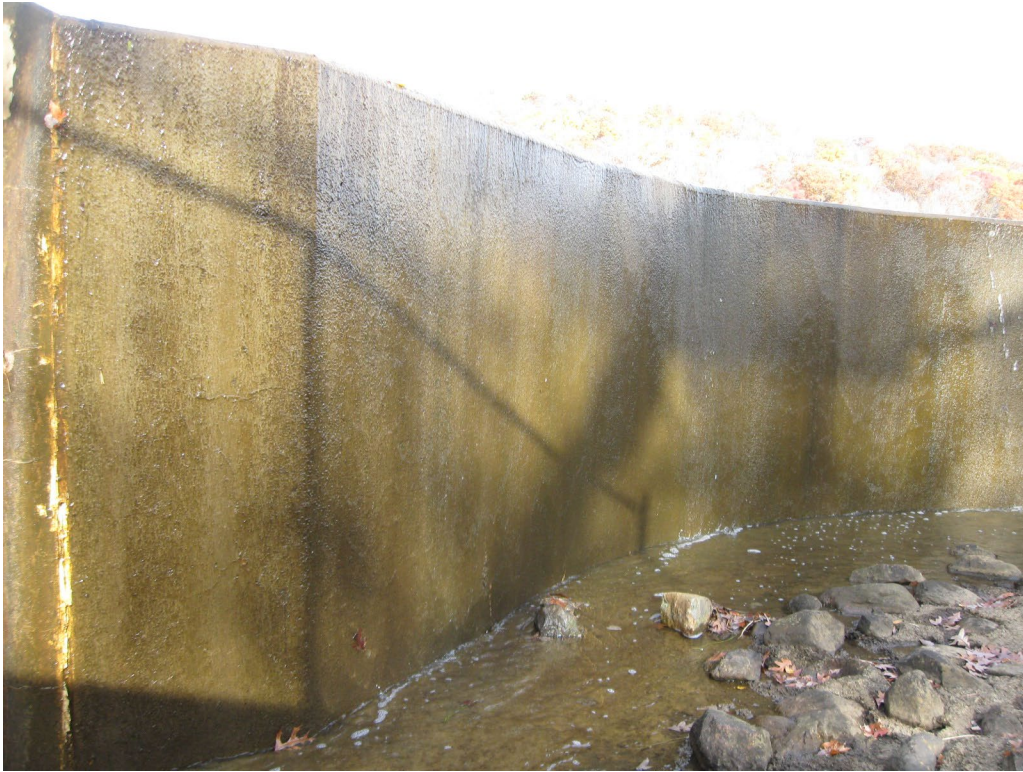
**Photo No. 21: Right side downstream face of spillway.**

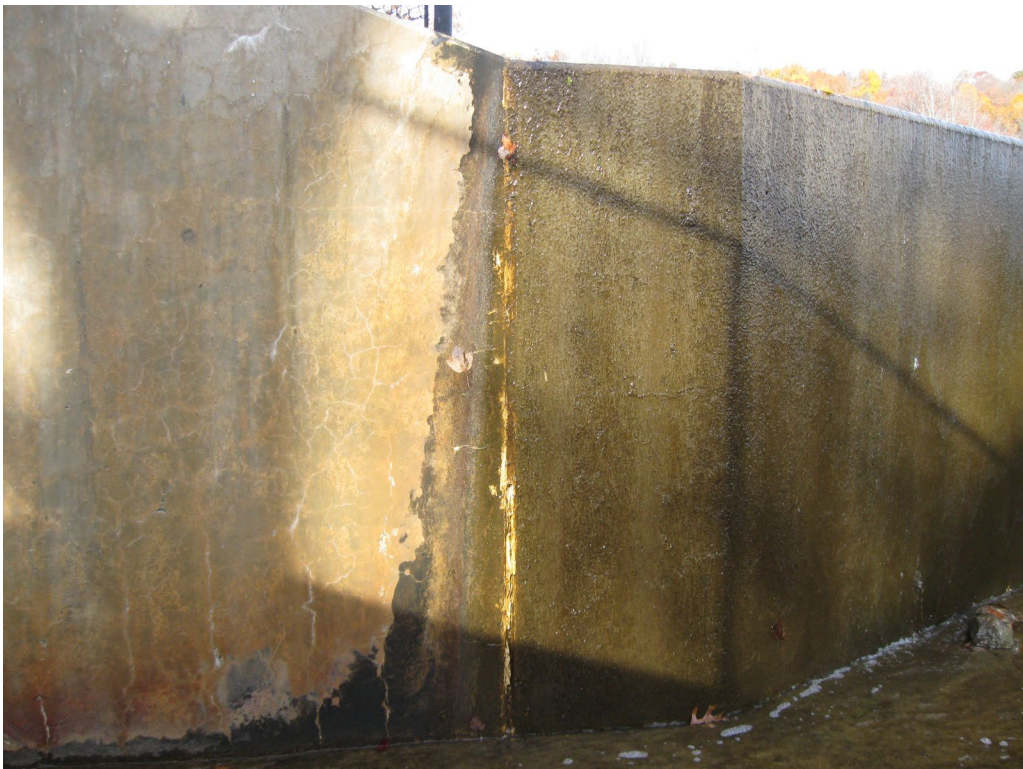
Joint filler material at the joints between the spillway and the training walls was missing along the bottom 2 feet of both walls during the 2020 inspection. Prior to this inspection, the Owner repaired the joint material but the material was showing signs of weathering and deterioration (drying, cracking).

**Photo No. 22: Joint between the spillway and the right side training wall.  
Note the the repaired joint material.**

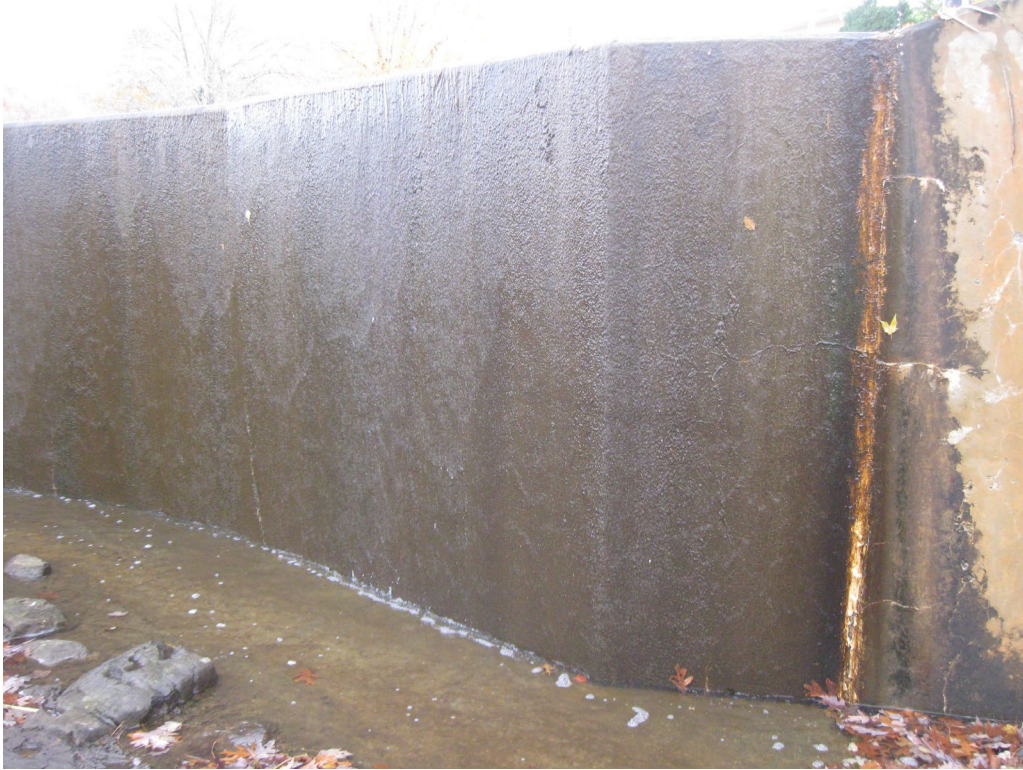
**Photo No. 23: Left side downstream face of spillway.**

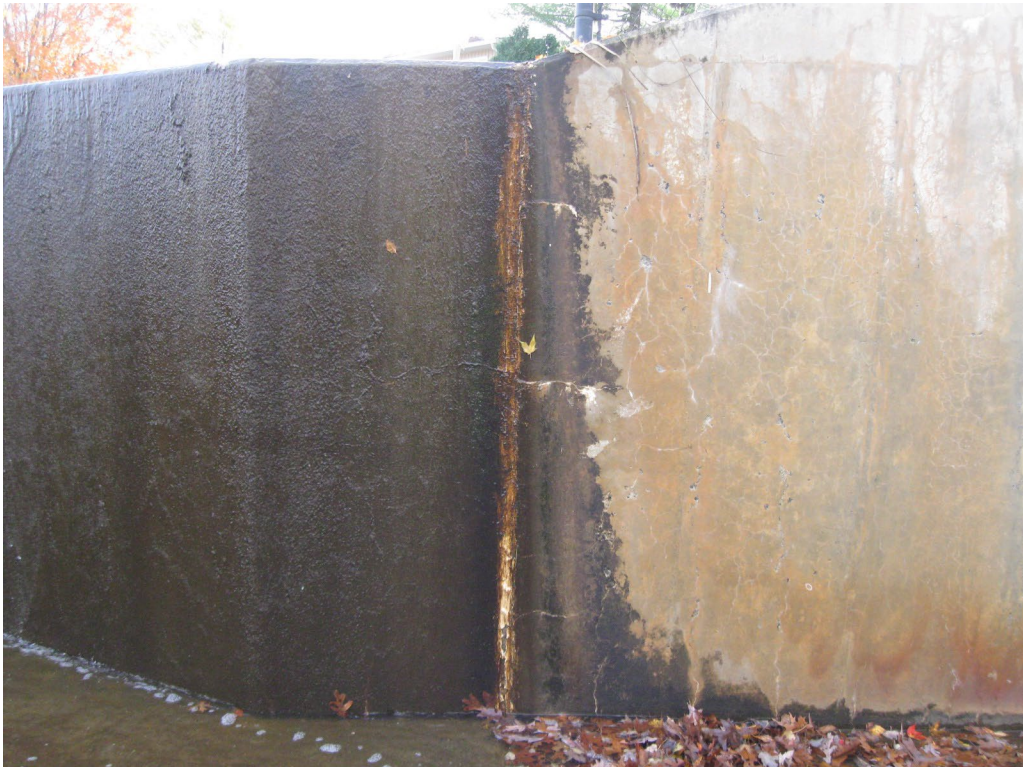
**Photo No. 24: Joint between the spillway and the left side training wall.  
Note the the repaired joint material.**

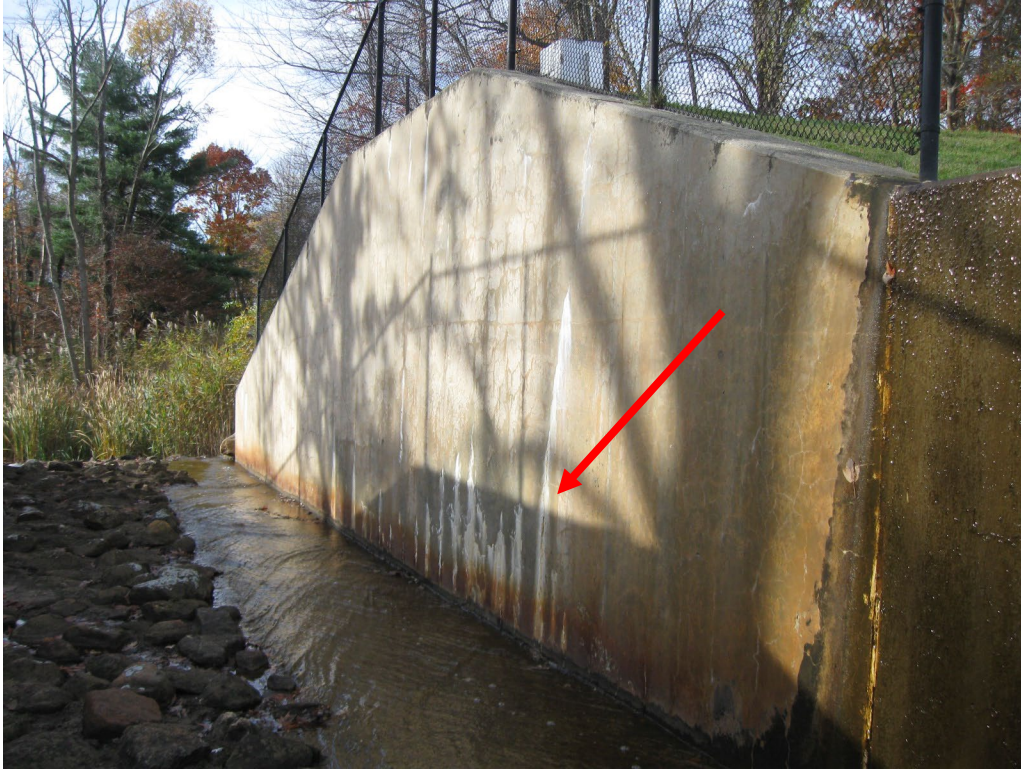
Several vertical cracks with efflorescence were observed at various spacing along both training walls. A few minor horizontal cracks with efflorescence were observed at the contacts between the training walls and spillway. Efflorescence appeared more prevalent on the right training wall. One 5-foot long (measured this inspection) horizontal crack and minor spall with efflorescence was observed at the downstream end of the right training wall. These conditions were observed during previous inspections and there did not appear to be any significant change in conditions since the 2020 inspection. A new horizontal crack was observed in the top of the right training wall extending from the downstream end of the wall to the fence post. The crack was open and significant, but it was just below the top of the wall and not a structural concern.

**Photo No. 25: Right side spillway training wall looking downstream.  
Note the efflorescence and cracking in the wall.**

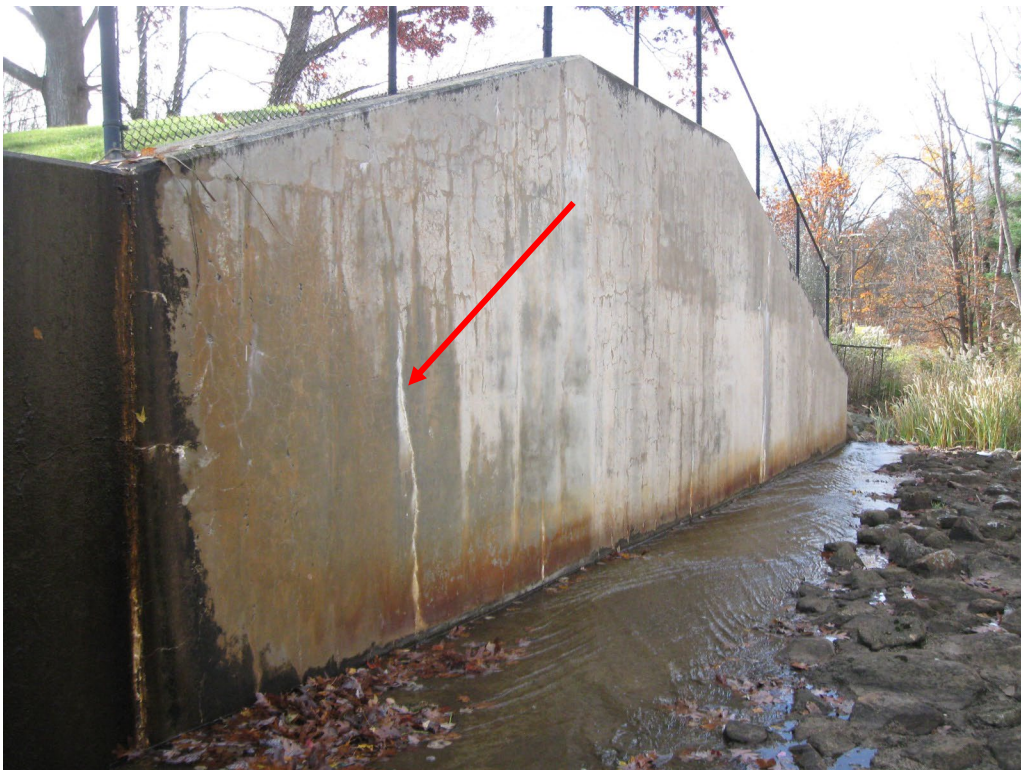
**Photo No. 26: Left side spillway training wall looking downstream.  
Note the efflorescence and cracking in the wall.**

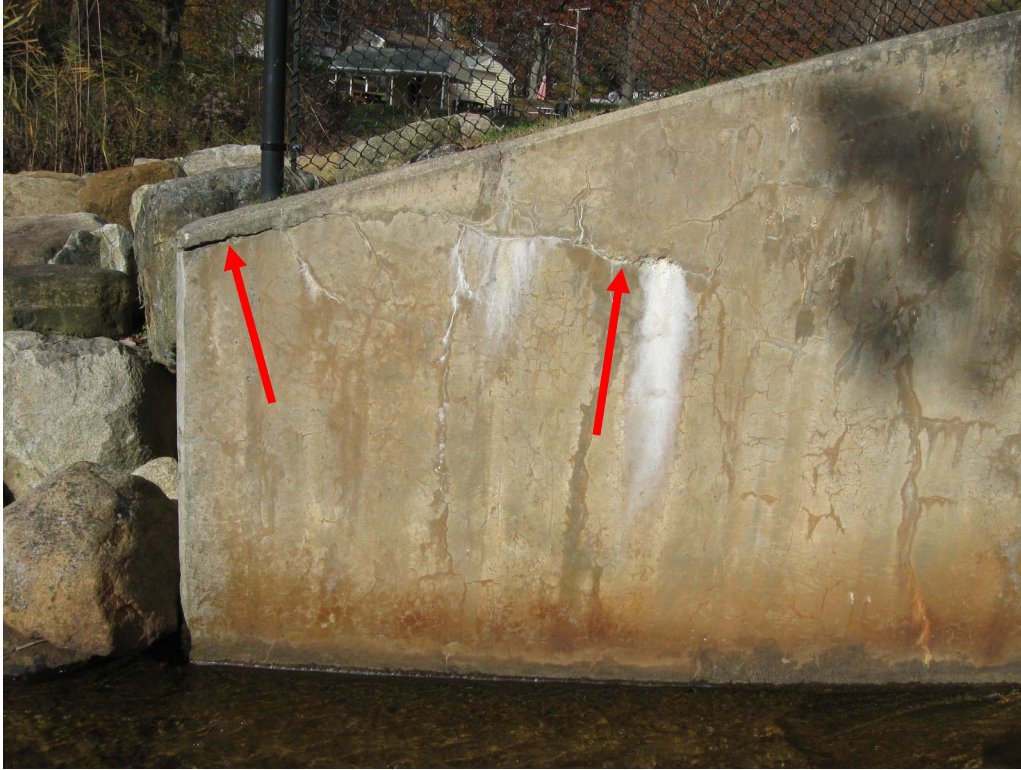
**Photo No. 27: Closeup of 5-foot long horizontal crack in the downstream end of the right spillway training wall.**
