# 2022 REGULAR INSPECTION REPORT

## SENECA LAKE DAM (NJDEP File No. 22-183)

Sparta Township  
Sussex County, New Jersey

**GZA GeoEnvironmental, Inc.**

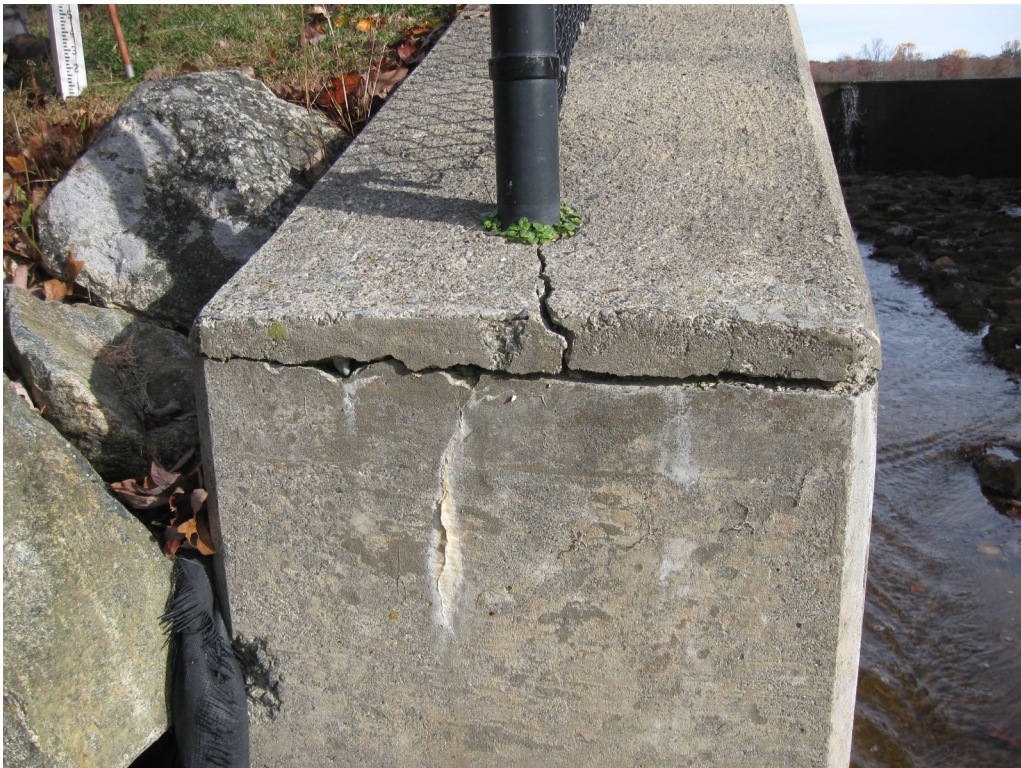
**Unusual Conditions:** Chain link fence located along top of both training walls. The fence appeared to be in good condition. The loose upstream post on the left side observed during the 2020 inspection was repaired. The fence on the downstream right training wall was loose due to the crack.

**Photo No. 28: Closeup of horizontal crack in the top of the right training wall extending from the downstream end of the wall to the fence post.**

1. **Continue to visually monitor cracks in the concrete spillway training walls.**
2. **Fill the minor voids between the spillway concrete footing and the grouted riprap apron.**

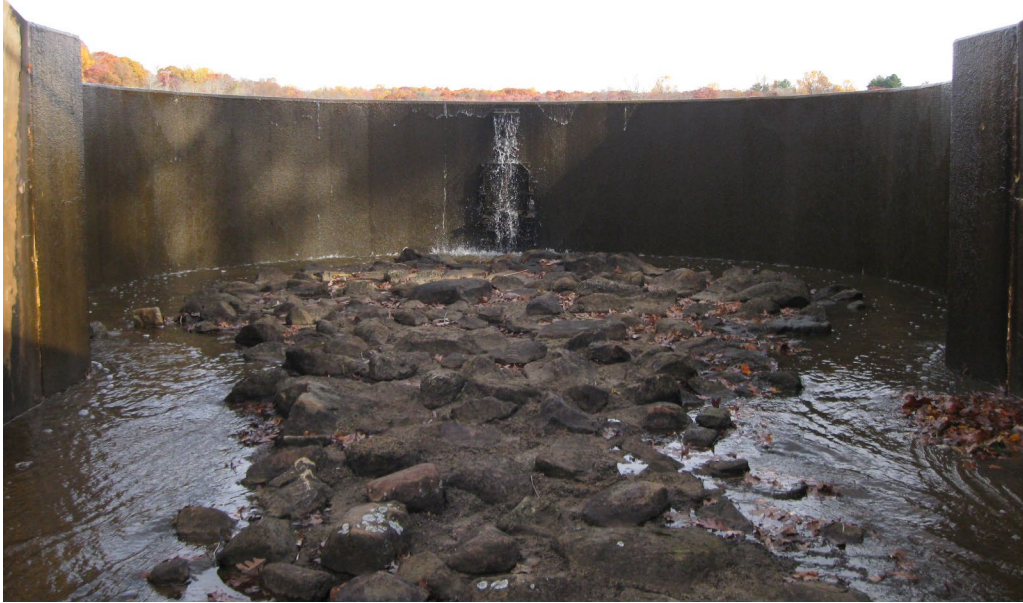
**Photo No. 29: Spillway and grouted riprap discharge channel looking upstream.**

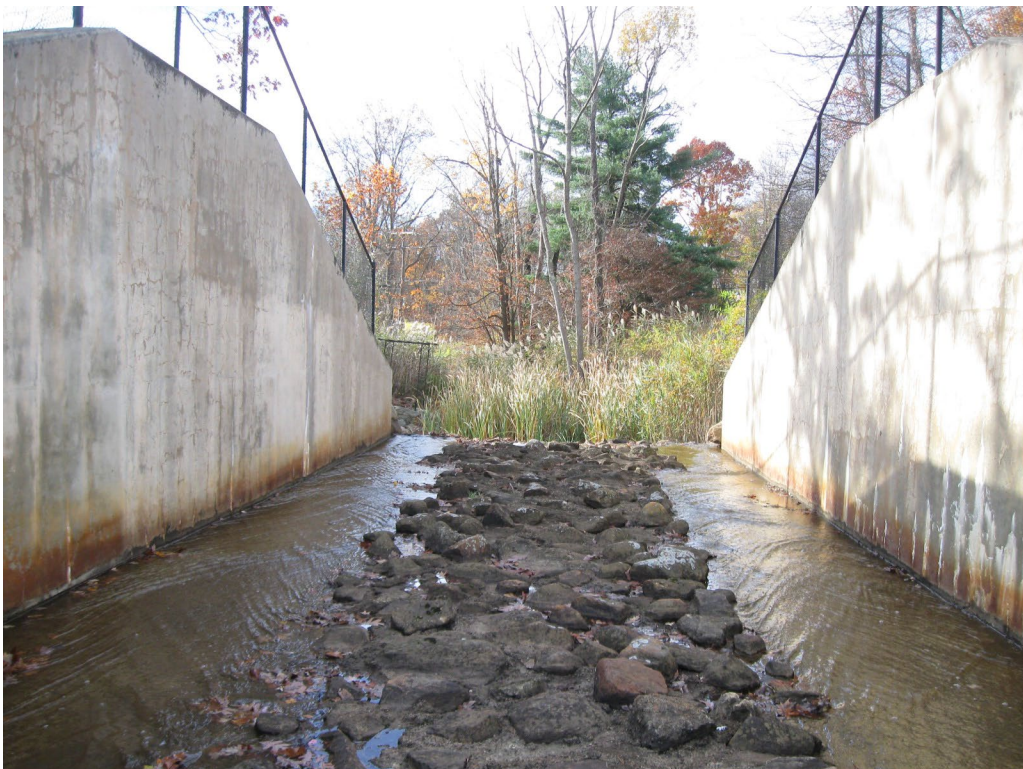
Grouted riprap appeared intact and in good condition with some missing stones near the downstream end of the training walls. No voids or significant cracks were observed in the grouted riprap. In general, conditions appeared similar to the 2020 inspection.

**Photo No. 30: Grouted riprap discharge channel looking downstream.**

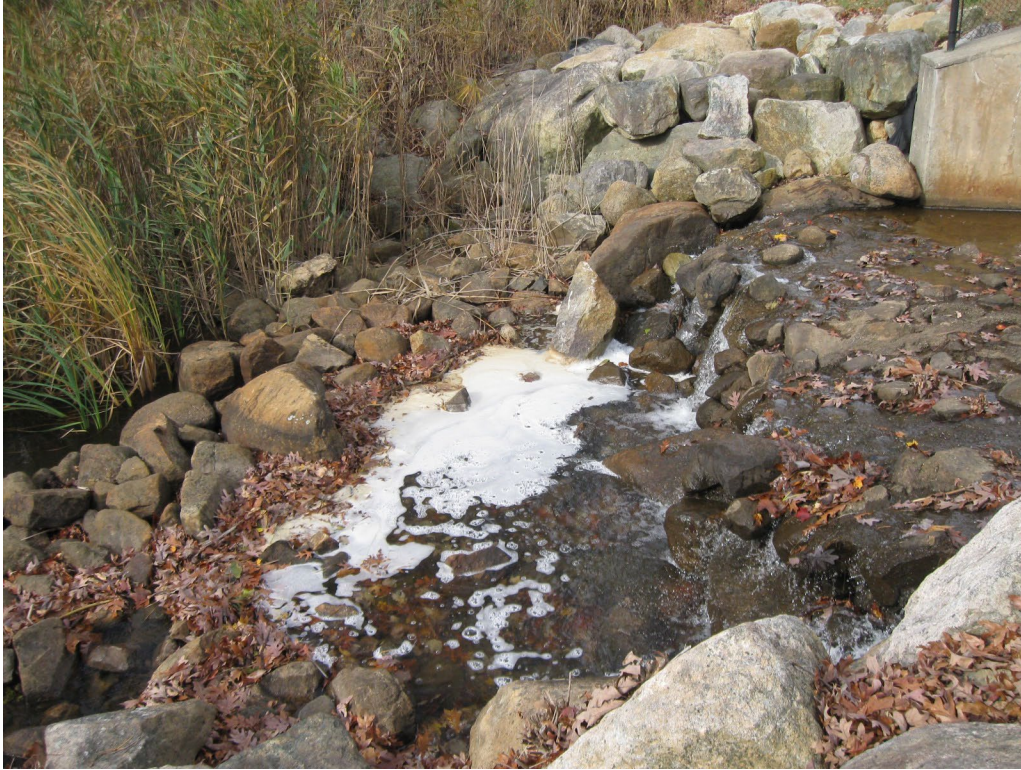
**Signs of Movement:** As observed during previous inspections, an area of the riprap apron was displaced. The Owner reported that some 12-inch riprap was recently added to the apron but the new riprap was submerged and not visible. Similar to previous inspections, the area of missing stone was measured at about 16 feet wide by 10 feet long by 1.5 feet deep. The apron needs to be repaired by adding larger riprap (at least 18-inch diameter) and grouting the voids to full depth.

**Unusual Conditions:** Transition area from discharge channel to apron is relatively steep, which could contribute to the movement of the riprap.

**Photo No. 31: Downstream riprap apron looking right.  
Note that some riprap was added since the 2020 inspection.**

1. **Repair the area of eroded downstream apron. Add large stone (18-inch diameter) and grout voids to full depth.**
2. **Cut the cattails in the plunge pool.**

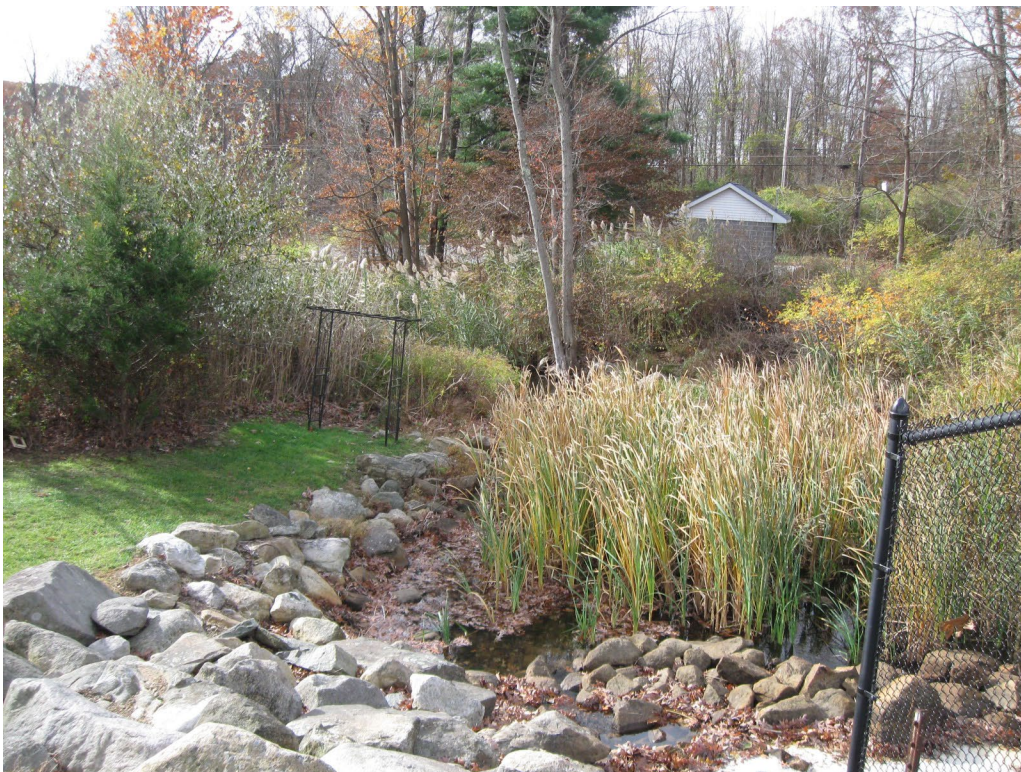
- Description:** Downstream riprap apron transitions into a riprap-lined plunge pool.
- Vegetation (trees, bushes):** Stand of thick cattails was established in the plunge pool. Several large trees and grassy vegetation were observed along the sides of the channel.
- Condition of Material:** The riprap was overgrown and difficult to observe, but riprap appeared to be in good condition where visible along the left side slope.
- Signs of Movement:** No movement was apparent other than the displaced riprap from the apron.
- Erosion:** No signs of erosion were apparent. Riprap in pool appeared to be stable but was difficult to observe due to overgrown conditions.
- Unusual Conditions:** None observed.

**Photo No. 32: Looking downstream at the plunge pool and exit channel  
toward the Tomahawk Trail bridge.**

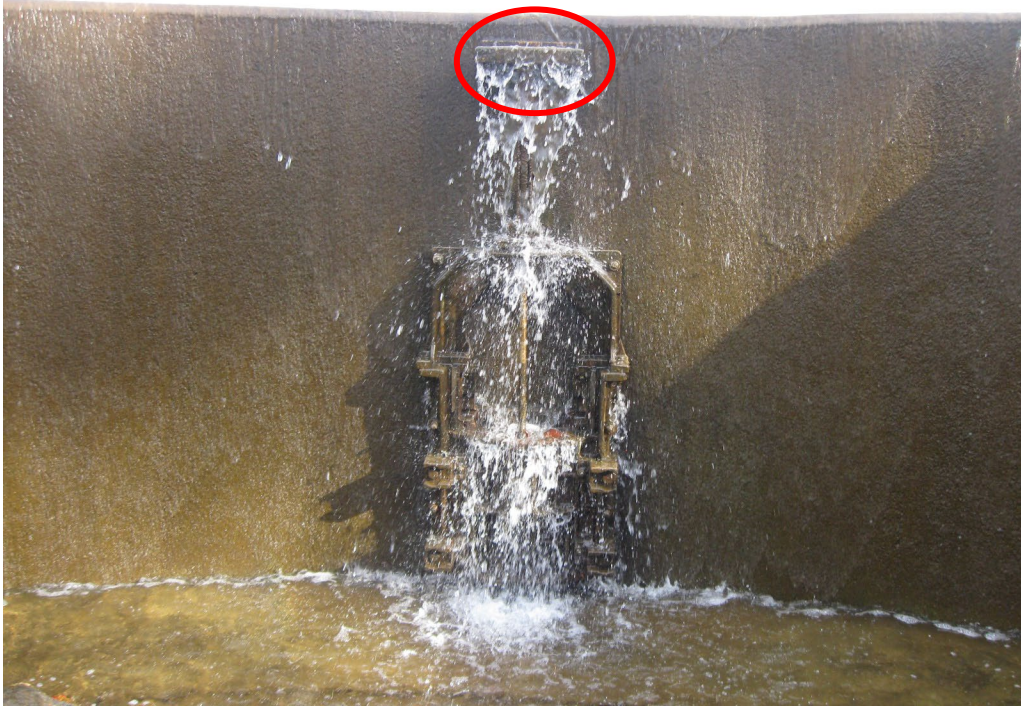
- Description:** 18-inch square sluice gate mounted on the downstream face of spillway. Sluice gate is controlled by a remote hydraulic operator that is located within an enclosure on the crest of the dam immediately right of the spillway training wall.
- Condition:** The Owner indicated that the sluice gate was operable, and no problems were encountered with the hydraulic operator during past operations. The enclosure was not opened during this inspection, but previous inspections noted that some rust was observed on the hydraulic cylinder encasement.
- Trash Rack:** None

**Photo No. 33: Closeup of the low-level outlet sluice gate.  
Note the deflection cover over the hydraulic operating cylinder.**

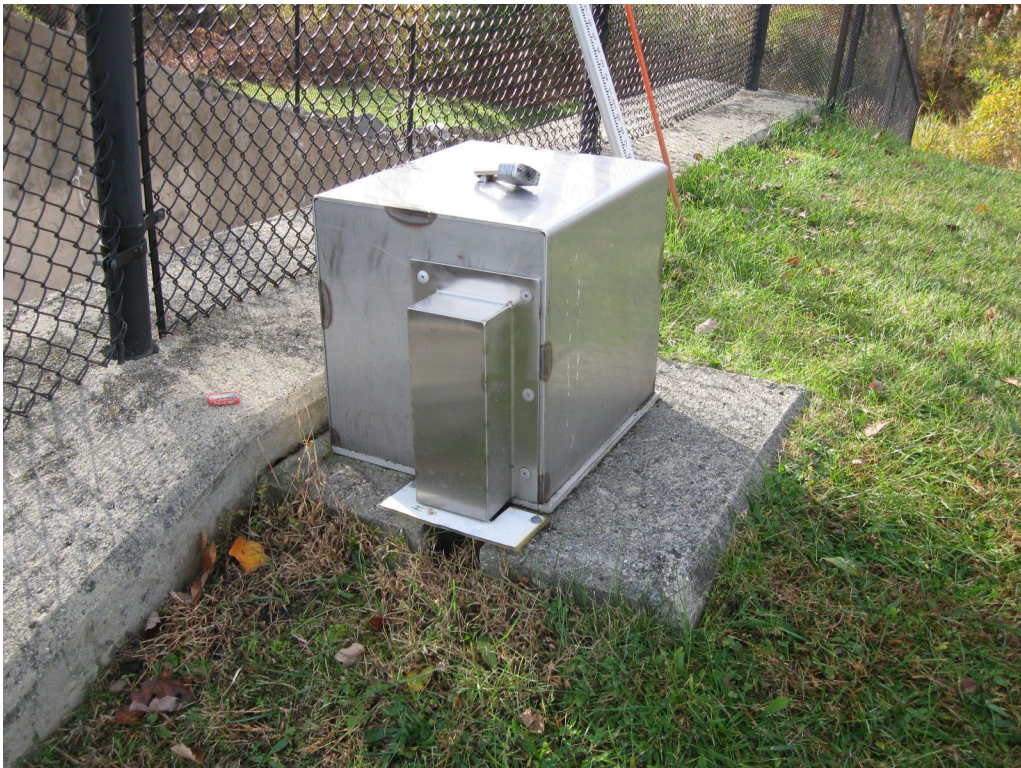
**Miscellaneous:** The hydraulic operator enclosure is located on the right-side dam embankment crest adjacent to the right spillway training wall. A steel plate covers a missing section of the enclosure's concrete footing. The lock on the operator enclosure was in place.

**Photo No. 34: Hydraulic operator enclosure for the  
low-level outlet sluice gate.**
