2024 REGULAR INSPECTION REPORT

SENECA LAKE DAM (NJDEP File No. 22-183)

Sparta Township
Sussex County, New Jersey

GZA GeoEnvironmental, Inc.

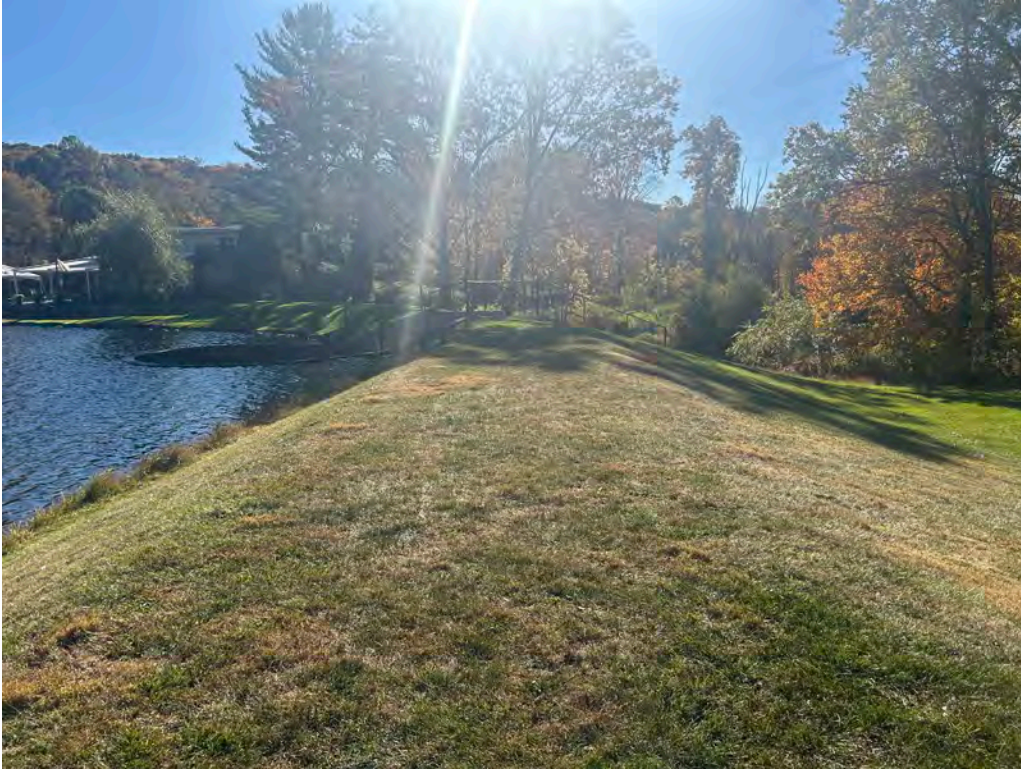
Photo No. 1: Right side dam crest looking left toward the spillway.

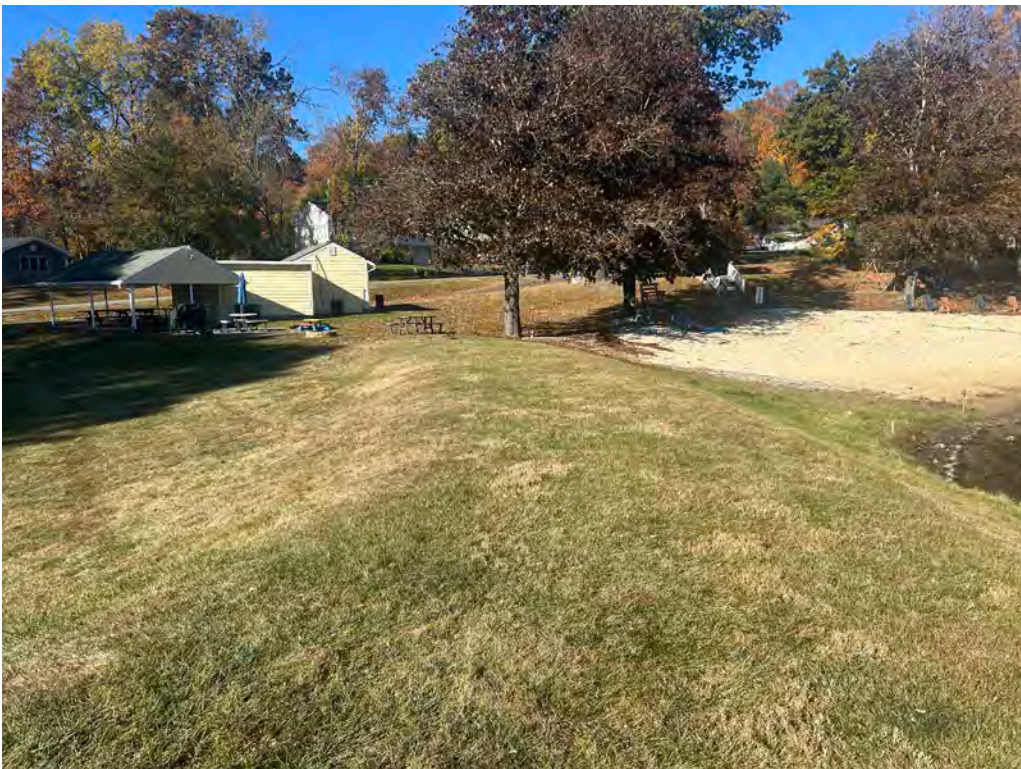
Photo No. 2: Right side dam crest looking right toward the right abutment.

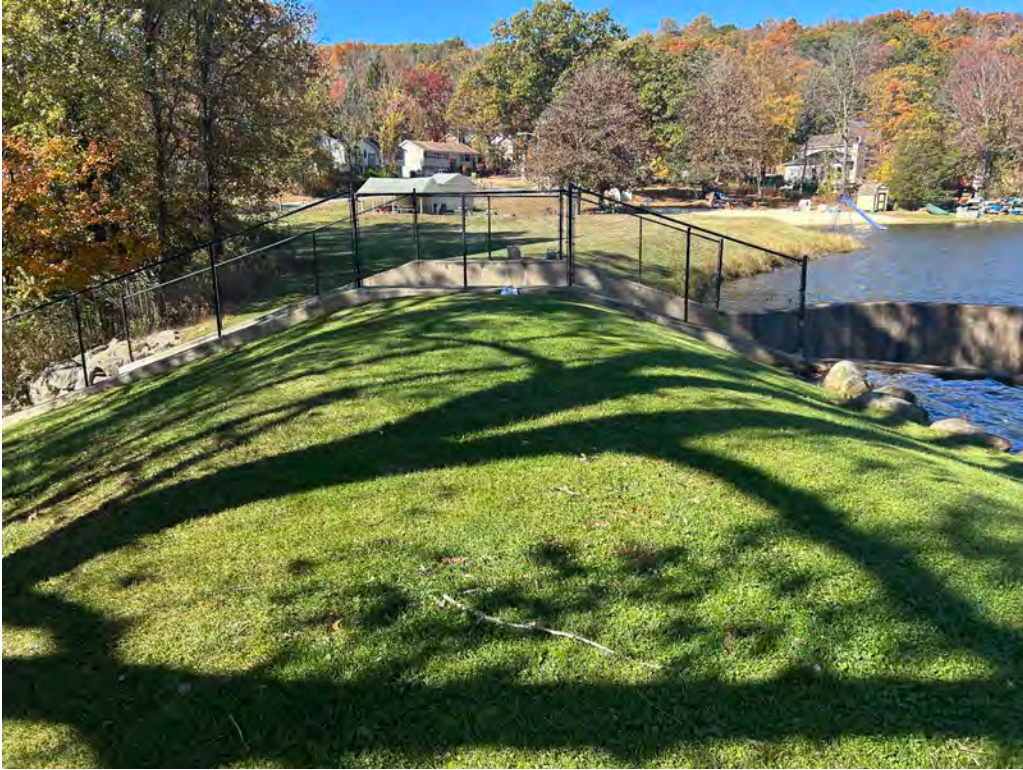
Photo No. 3: Left side dam crest looking right toward the spillway.

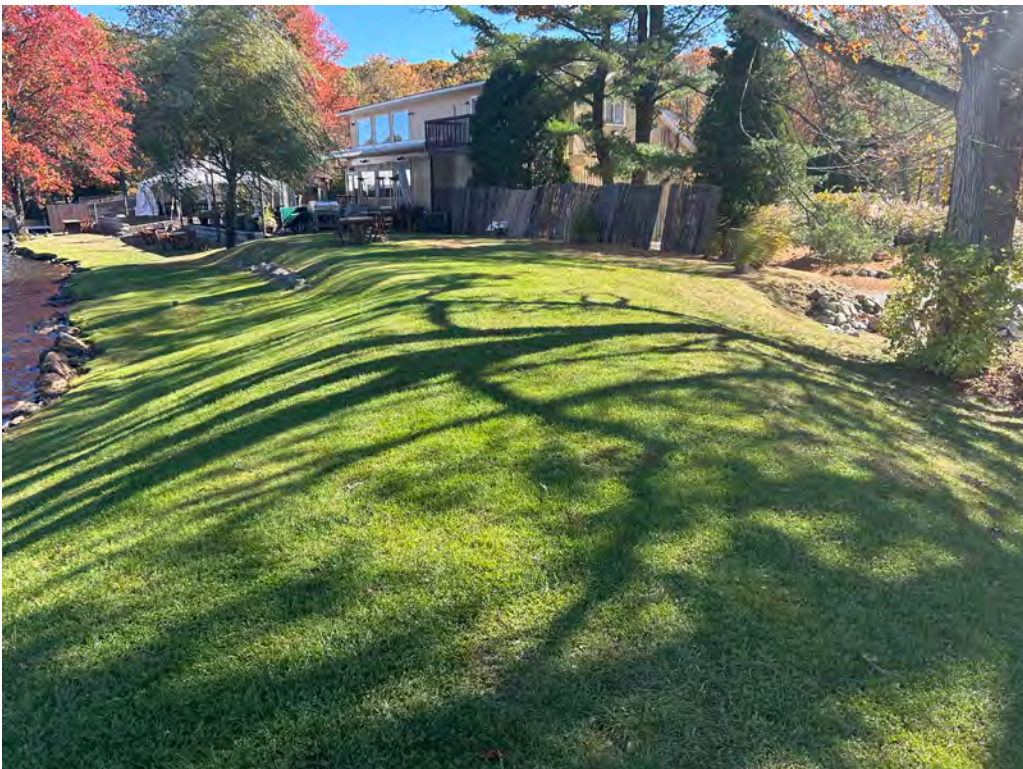
Photo No. 4: Left side dam crest looking left toward the restaurant and dike.

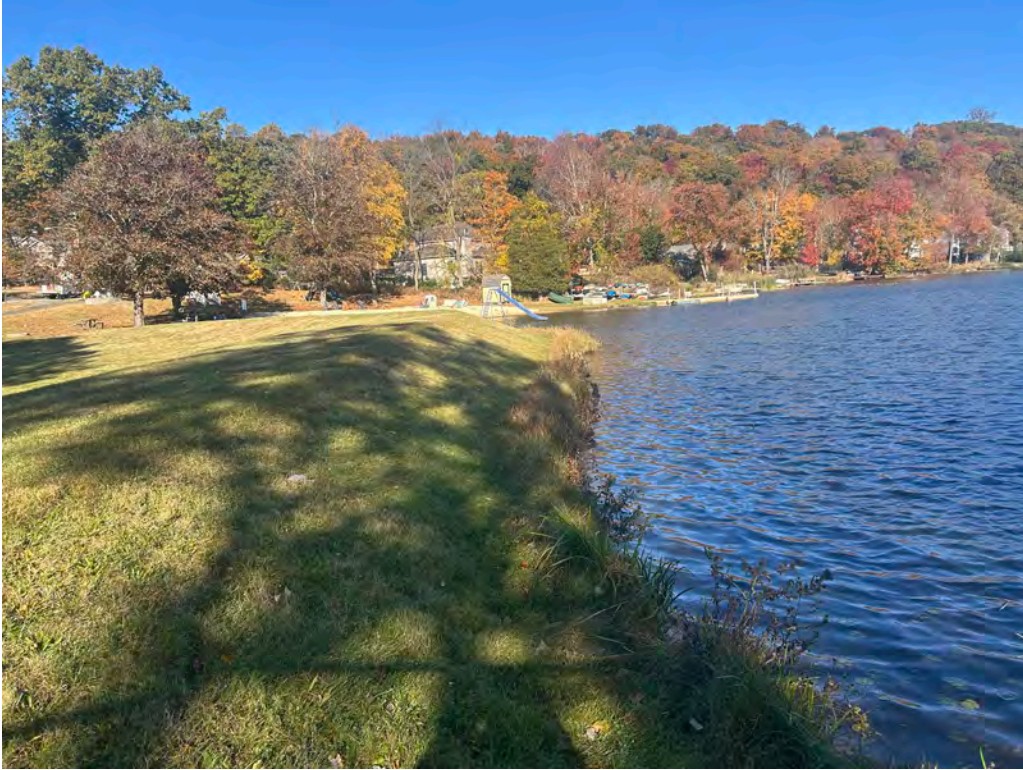
**Photo No. 5: Right side upstream slope of the dam
looking right toward the bend.**

1. **Cut weedy/woody vegetation on the right side upstream slope along the lake edge.**
2. **Repair settled area of upstream slope along the left spillway training wall.**
3. **Add topsoil to eroded area at top of downstream slope left of the spillway. Reseed the area to establish grass cover.**
4. **Repair the crack in the grouted riprap discharge channel between the training walls.**
5. **Fill the minor void between the spillway concrete footing and the grouted riprap apron on the left side.**

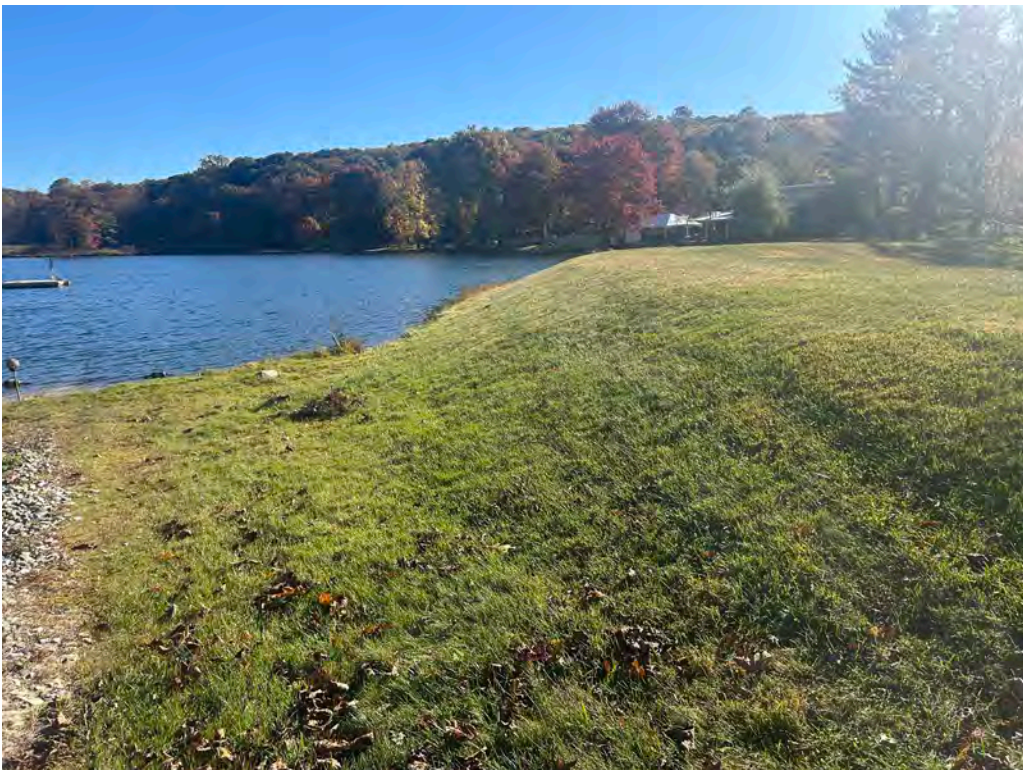
**Photo No. 6: Right side upstream slope of the dam
looking left toward the bend.**

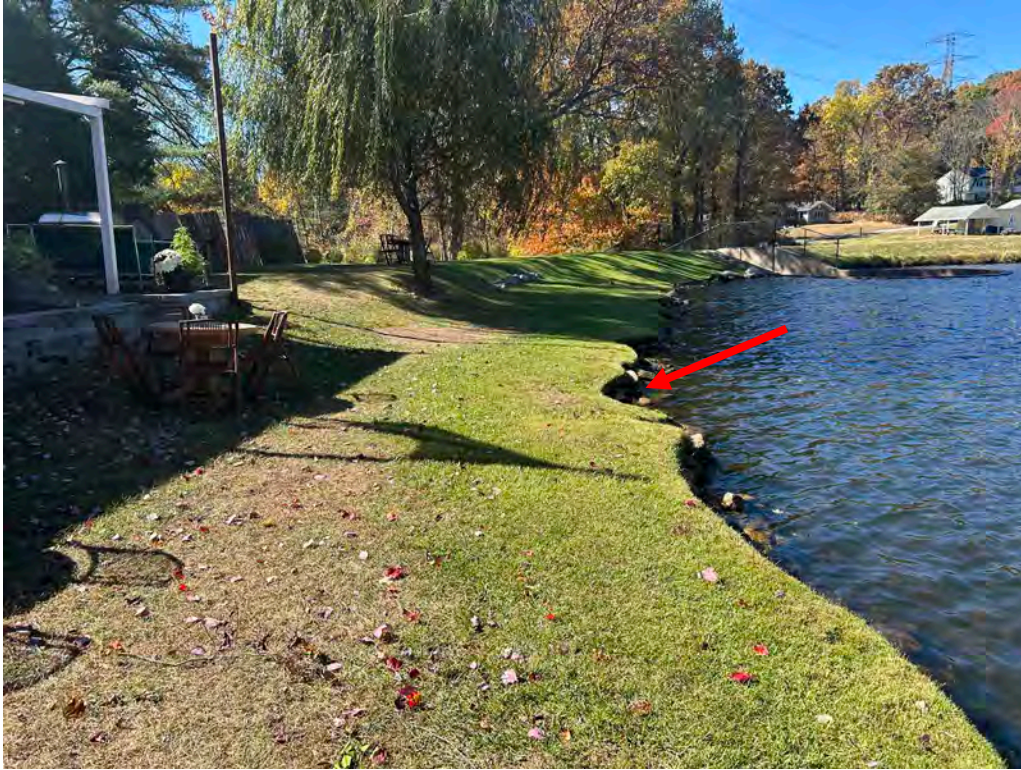
**Photo No. 7: Left side upstream slope of the dam looking right toward the spillway.
Note the scarping along the lake edge at the bench.**

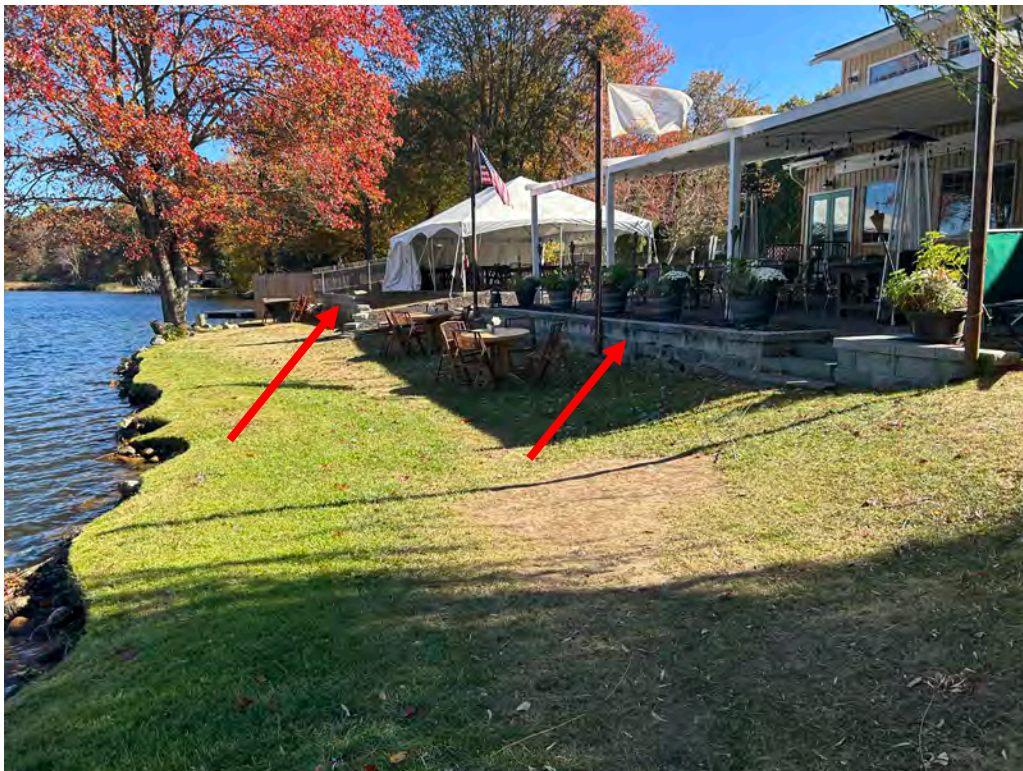
A short segmental block retaining wall was constructed along the outdoor dining area just upstream of the restaurant on the left side between the 2016 and 2018 inspections. Prior to the 2020 inspection, an additional section of retaining wall was added to the left to expand the outdoor dining area. Based on a comparison with photos from 2022, no significant additional modifications were observed in the outdoor dining area during this inspection.

**Photo No. 8: Left side upstream slope of the dam looking left along the restaurant.
Note the segmental block retaining walls.**

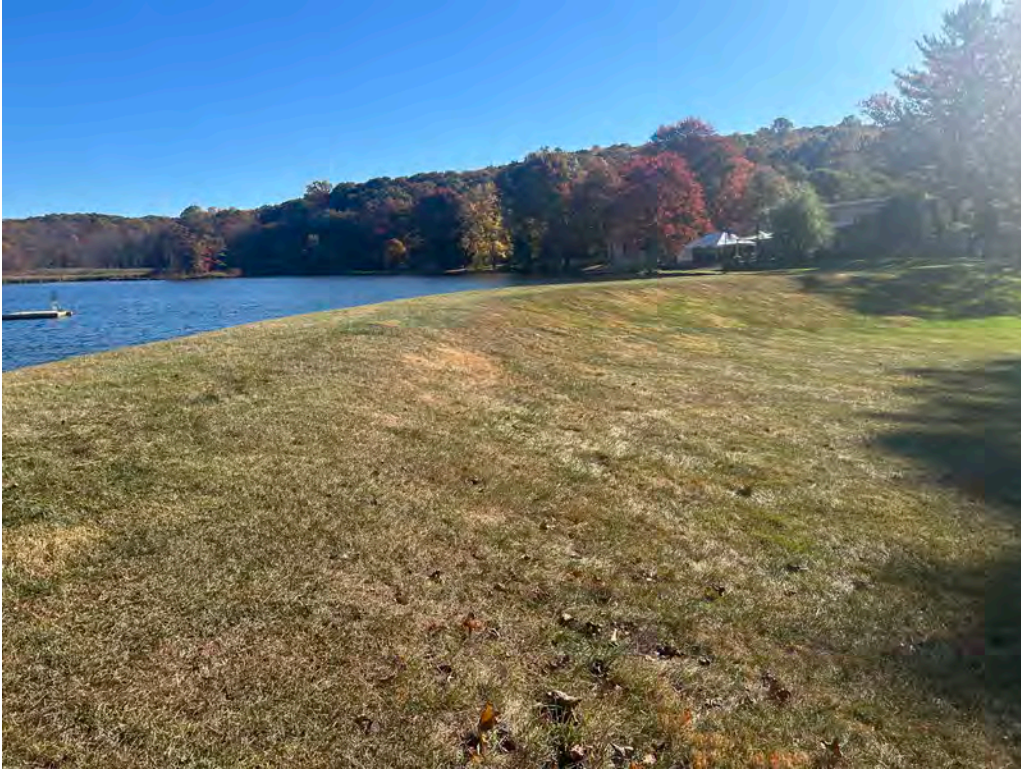
Photo No. 9: Right side downstream slope and toe of the dam looking left toward the spillway.

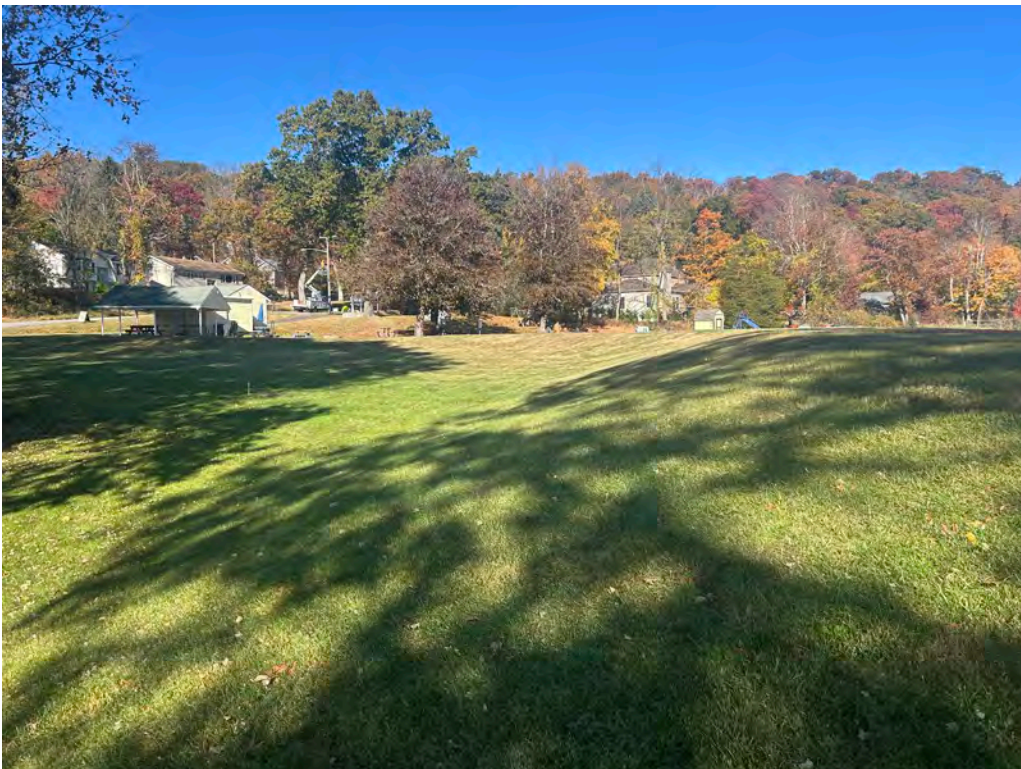
Photo No. 10: Right side downstream slope and toe of the dam looking right toward the right abutment.

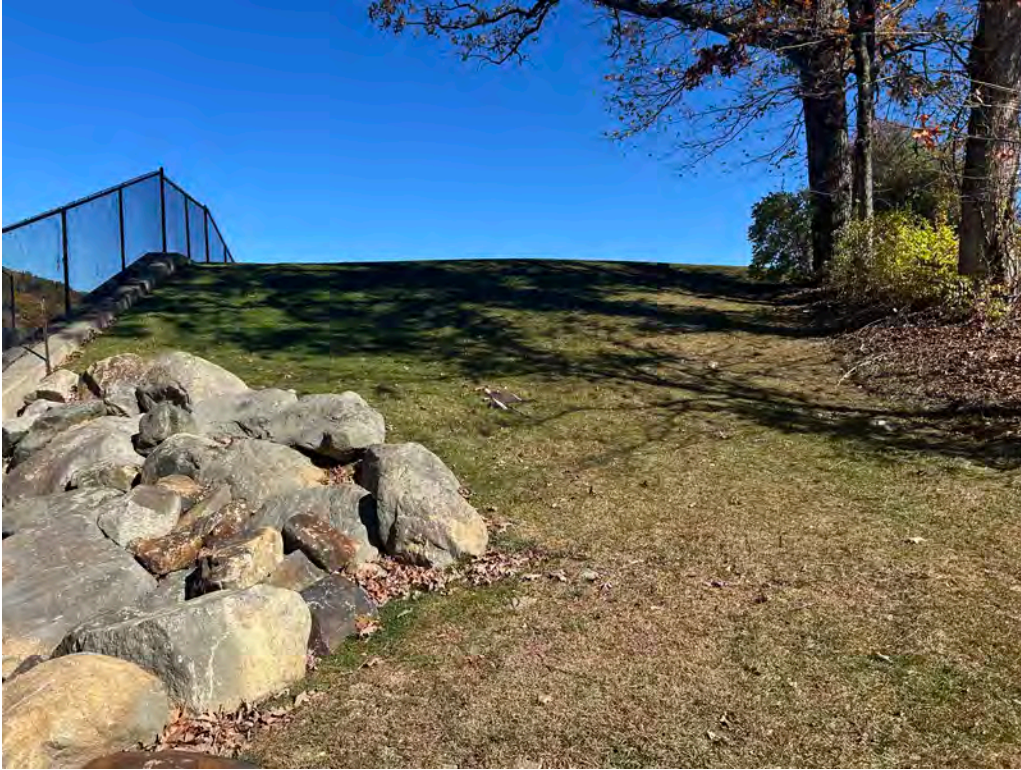
Photo No. 11: Left side downstream slope of the dam looking upstream from the toe.

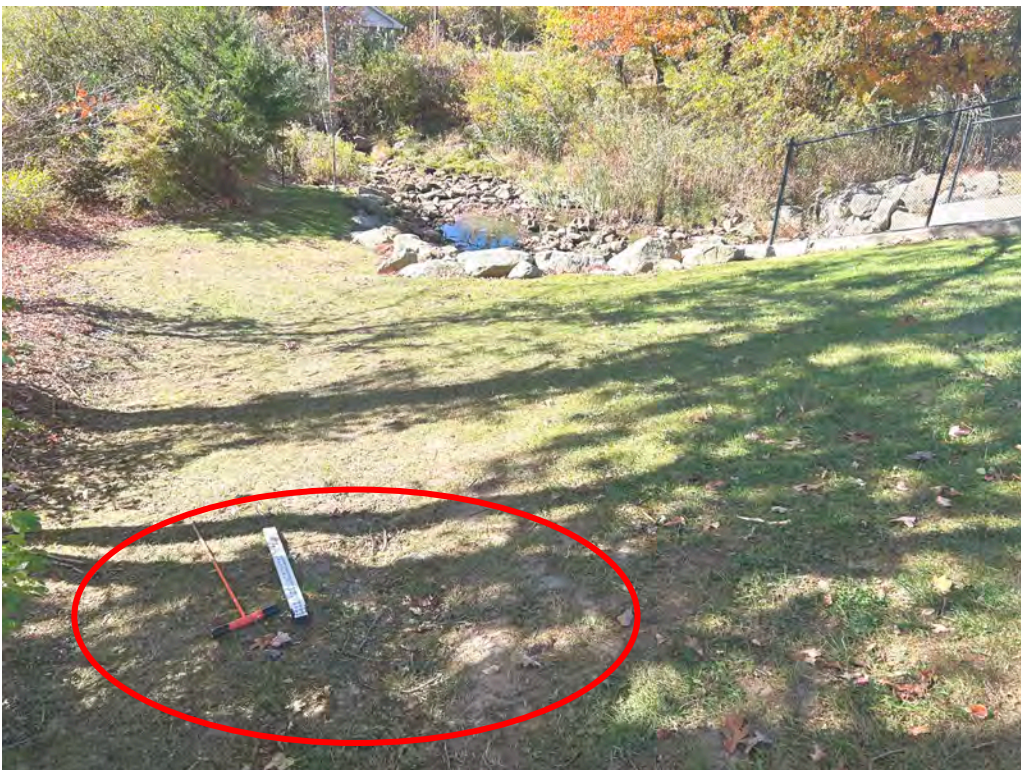
Sloughing, Subsidence or Depressions: Minor erosion of downstream slope was observed at the top of slope to the left of the spillway. No other problems were observed.

Photo No. 12: Left side downstream slope of the dam looking downstream. Note the area of minor erosion on the slope.

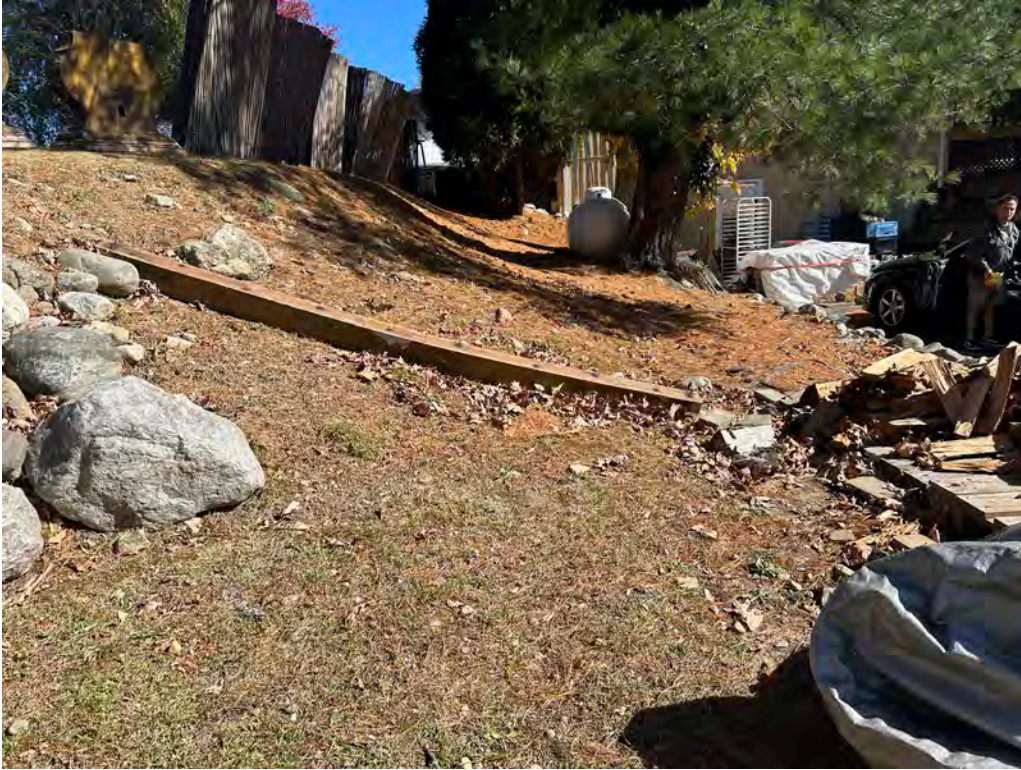
Photo No. 13: Left side downstream slope of the dam looking left toward the restaurant.

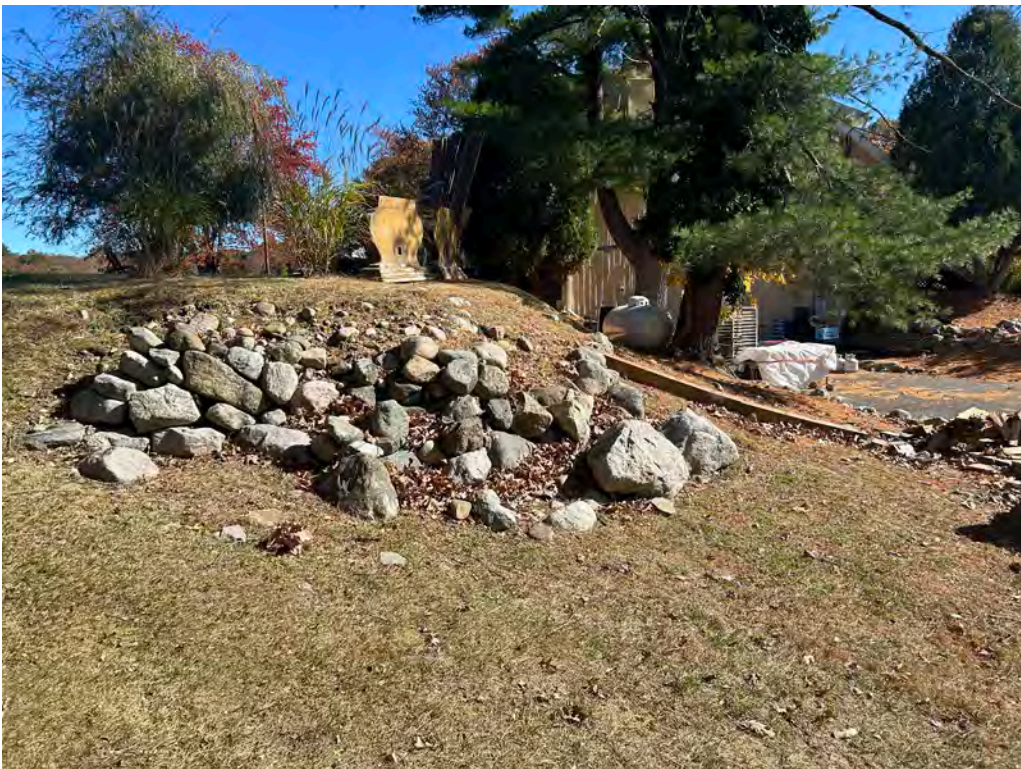
Some smaller stones in the rock rubble wall near the restaurant were displaced mid-slope. This condition was observed during the 2018, 2020 and 2022 inspections. No significant change was observed since the 2022 inspection.

Photo No. 14: Closeup of the rock rubble wall on the left side downstream slope of the dam looking left toward the restaurant.

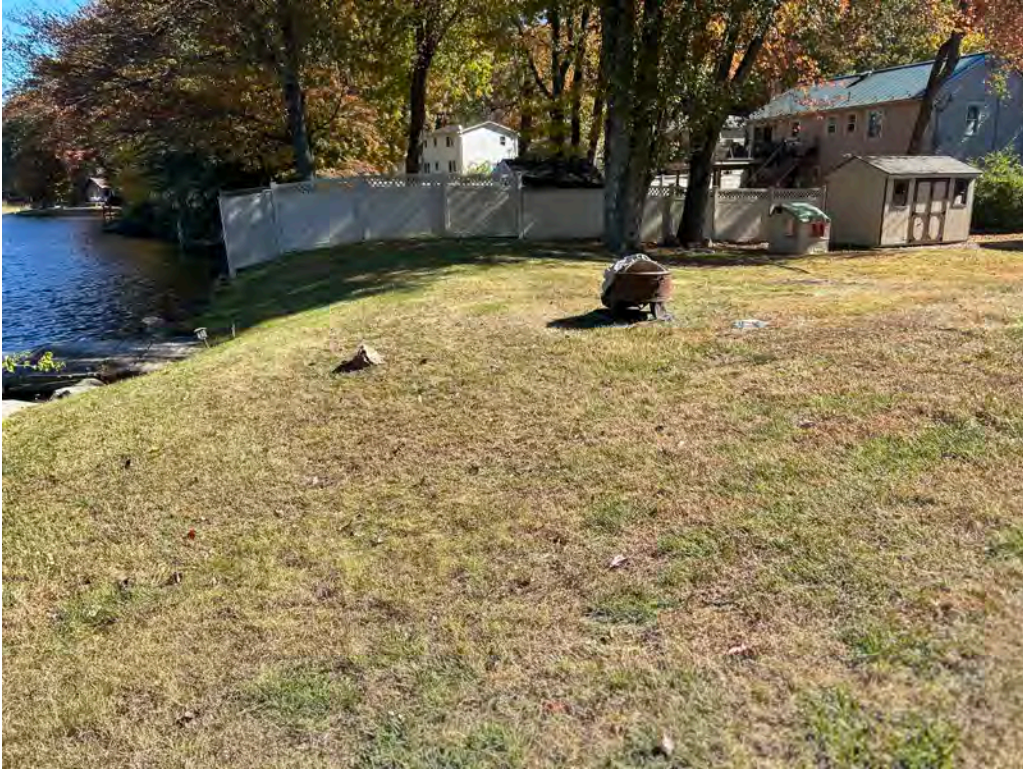
The saddle dike is a 140-foot long earthen embankment located about 250 feet to the east (or left) of the primary spillway. The dike appeared stable and in generally good condition. The crest and slopes appeared to be well maintained with good grass cover. A 6-foot high PVC privacy fencing is located over the berm between Lots 114 and 113 and Lots 113 and 112 of Block 3001. Short sections of wrought iron fencing extend from the ends of the PVC fencing into the lake. Rocks line the lake edge from the spillway to the left end of the dike. No problems were observed or apparent at the dike and conditions appeared similar to the 2022 inspection.

Photo No. 15: Dike on Lot 113 looking left.

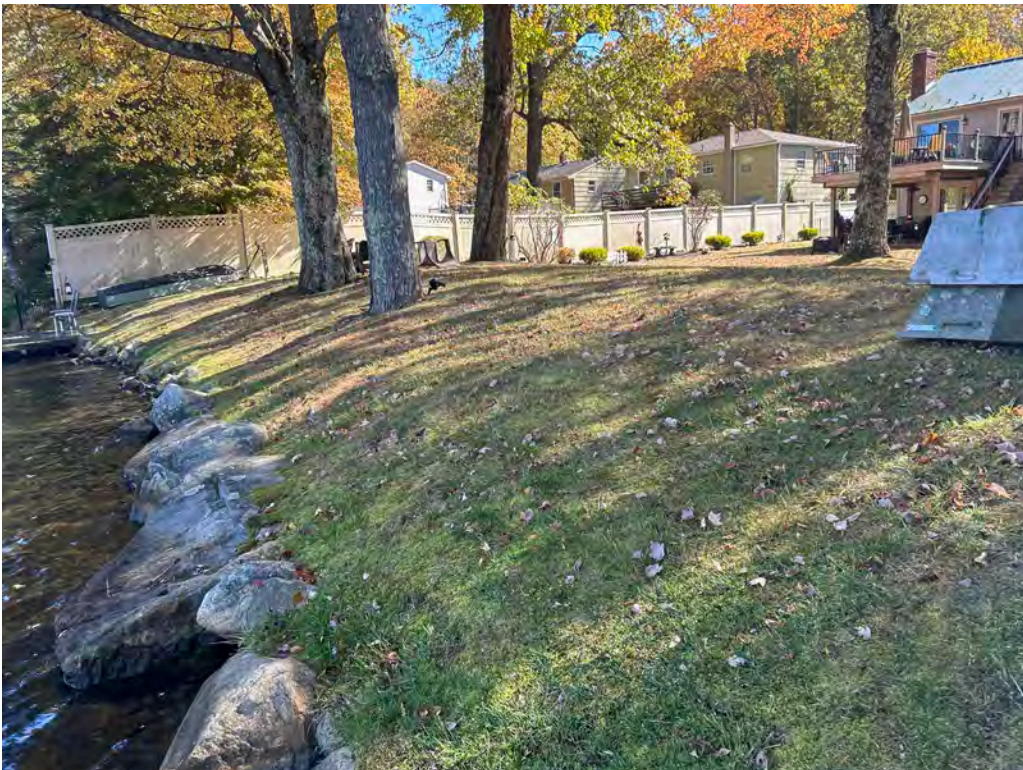
Photo No. 16: Dike on Lot 112 looking left.

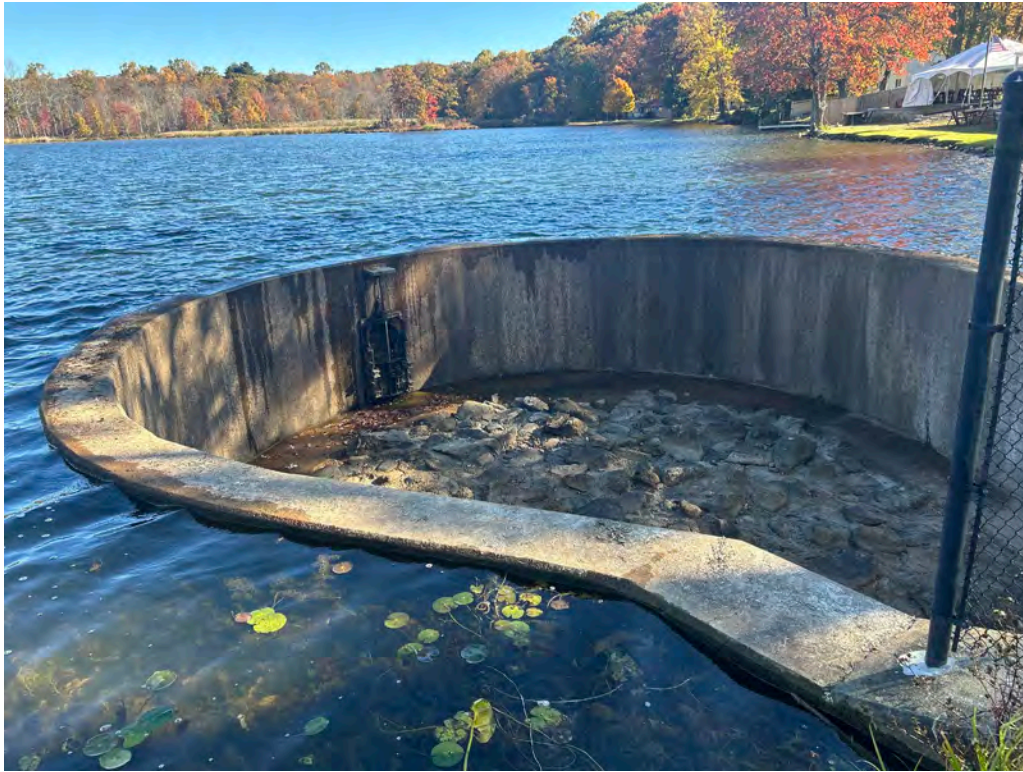
- Description:** 70-foot long semi-circular concrete overflow weir.
- Condition of Material:** Concrete appeared intact and in generally good condition. No significant cracks or spalls were observed on the crest or downstream face of the spillway. Minor shrinkage cracks with efflorescence were observed along the base of the downstream face of the spillway. No significant change in conditions was apparent since the 2022 inspection.

Photo No. 17: Spillway entrance, crest and downstream face looking left.

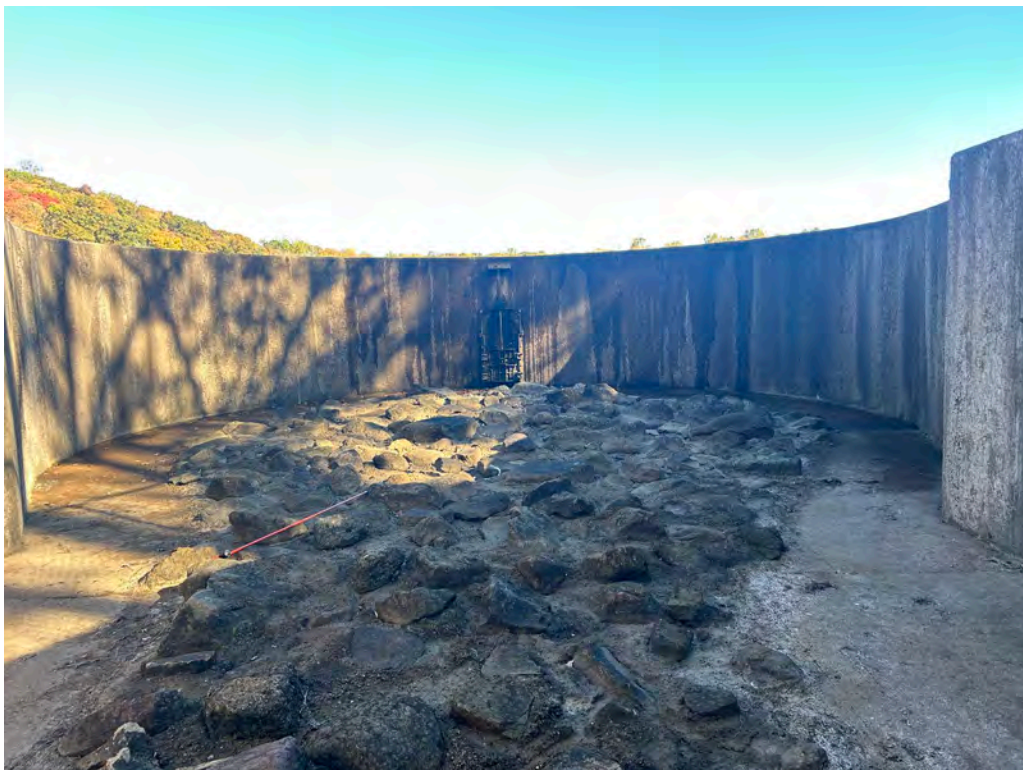
Photo No. 18: Downstream face of spillway looking upstream.

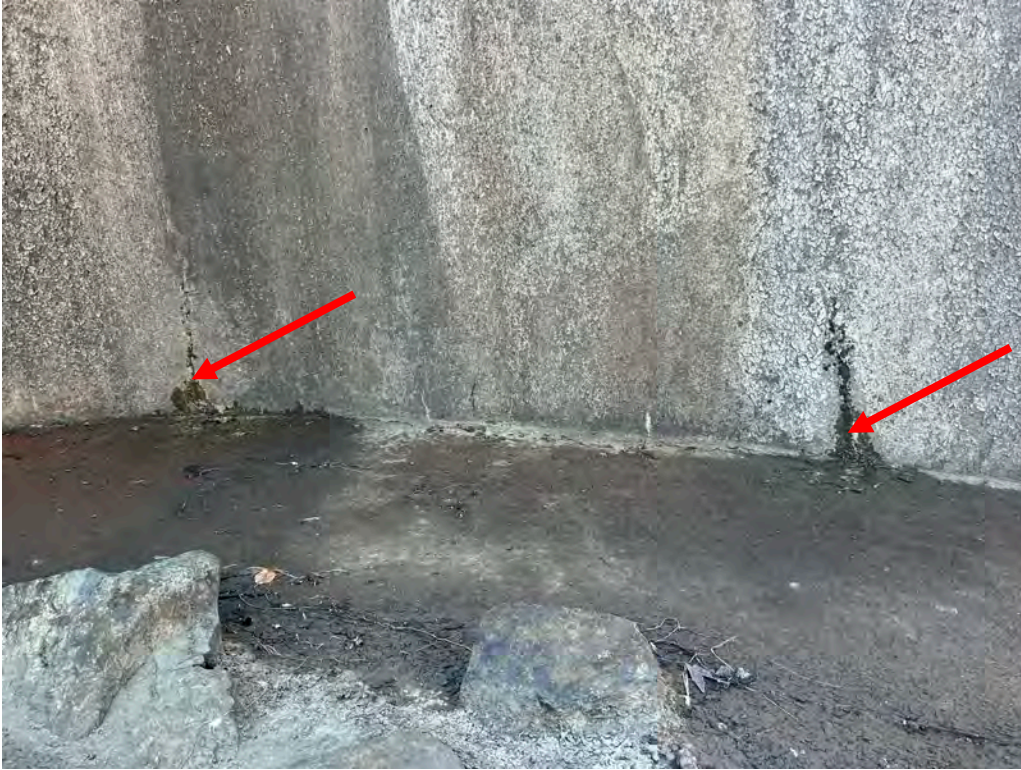
- Leakage:** A few minor weeps were observed through shrinkage cracks on the downstream face near the bottom of the weir. Flow rate was too small to measure. Portions of the spillway downstream face were wet due to wave action from windy conditions, but no leakage was apparent at the joints. .

Photo No. 19: Minor weeps in the downstream face of spillway.

1. **Visually monitor weeps in the spillway and training walls. Reports any changes in rate and/or color.**
2. **Continue to visually monitor cracks in the concrete spillway training walls.**

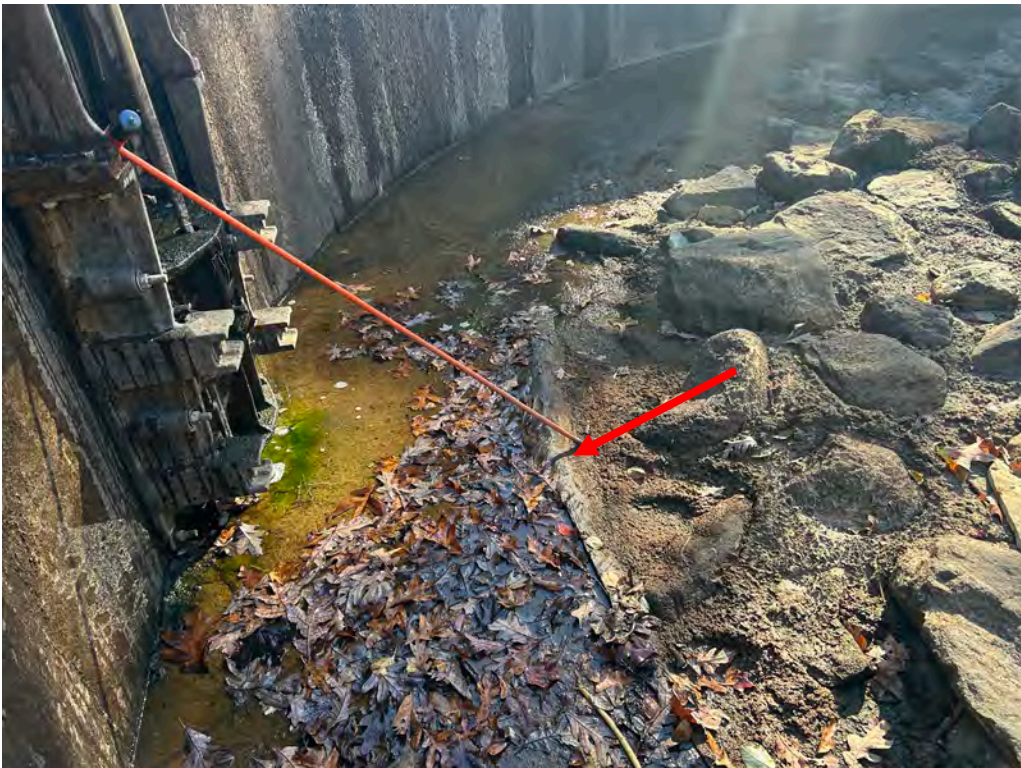
- The contact between the spillway downstream face and concrete footing appeared intact. During previous inspections, voids were observed in the center of the spillway between the right and left joints. The voids at the center of the spillway were repaired in November 2023 and the repairs appeared intact.

Photo No. 20: Repaired void between the spillway footing and the grouted riprap apron.

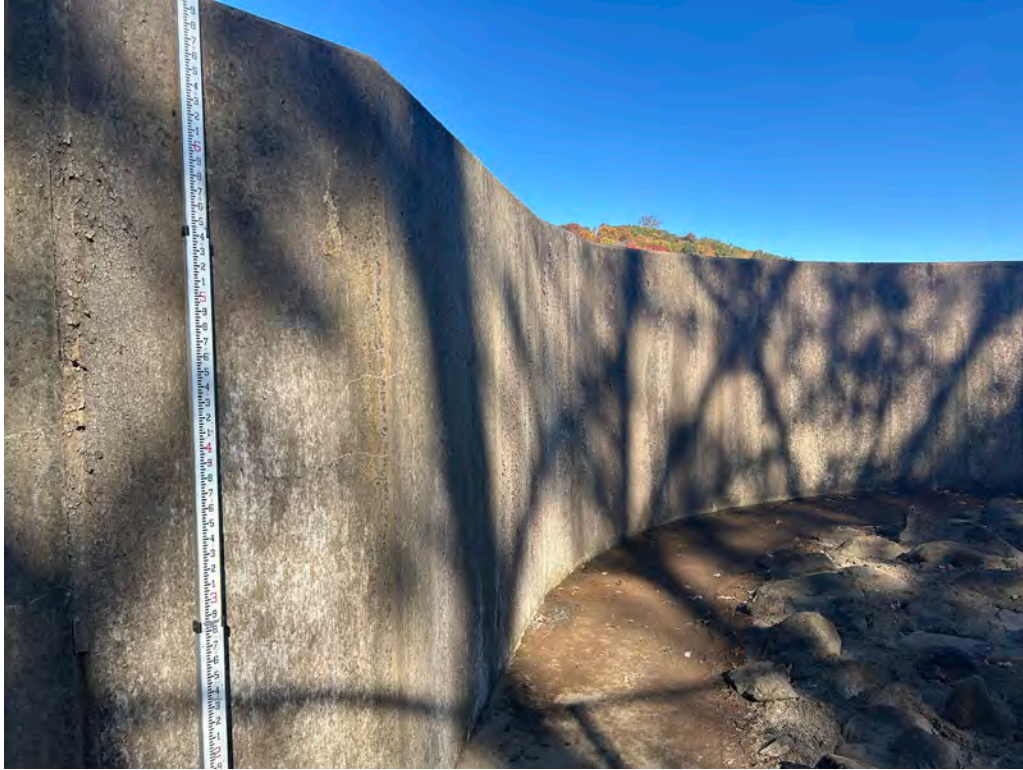
Photo No. 21: Right side downstream face of spillway looking upstream.

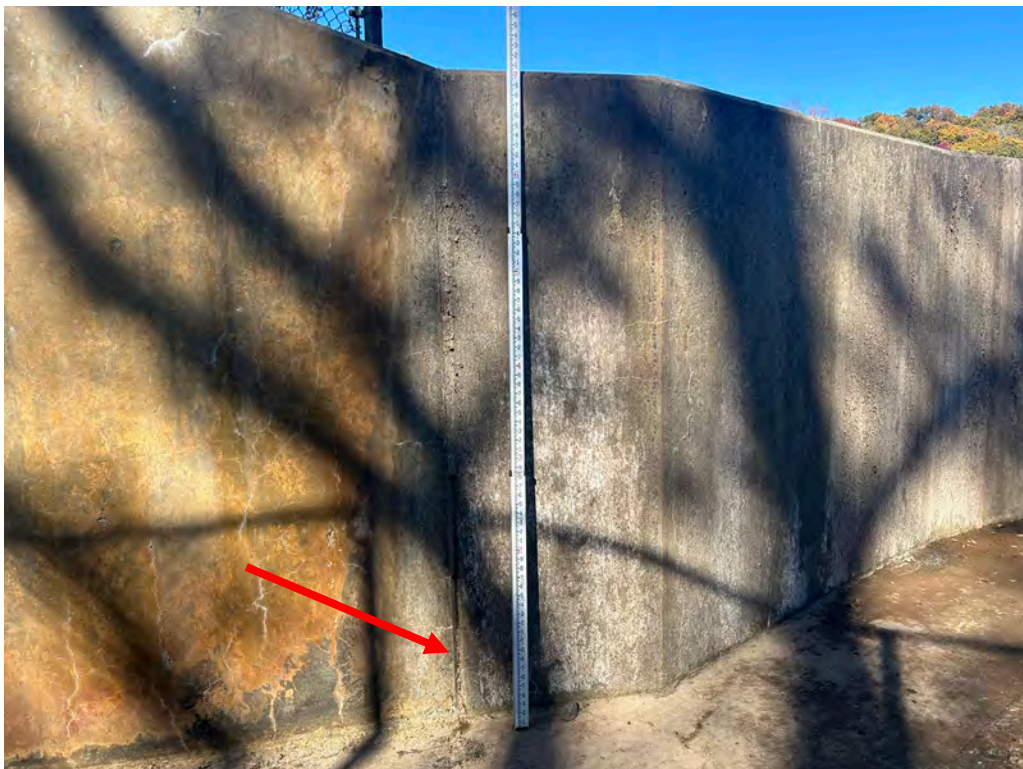
- Following the 2020 inspection, the Owner repaired the joint material at the joints between the spillway and the training walls. The material was showing signs of weathering and deterioration (drying, cracking) during the 2022 inspection. During this inspection, the joint filler material was missing along the bottom 2 feet of both walls similar to conditions observed during past inspections.

**Photo No. 22: Joint between the spillway and the right side training wall.
Note the the missing joint material.**

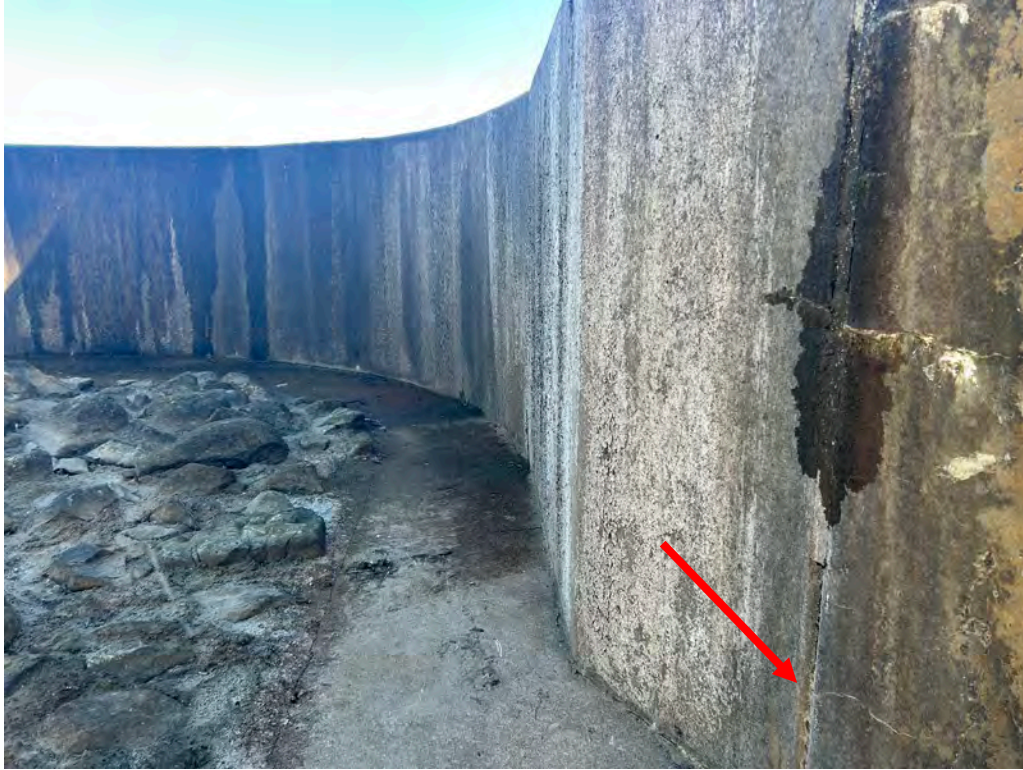
**Photo No. 23: Left side downstream face of spillway looking upstream.
Note the the missing joint material.**

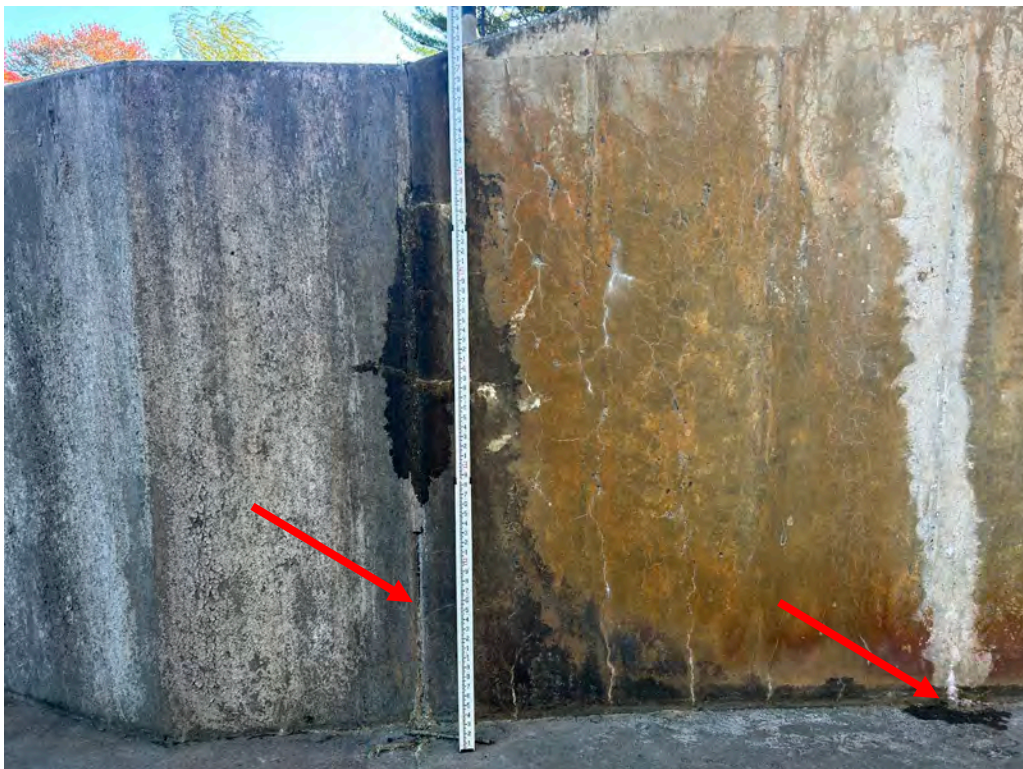
Leakage: A minor weep was observed in a crack in the bottom of the left training wall near the upstream end of the wall. Flow rate was too small to measure.

**Photo No. 24: Joint between the spillway and the left side training wall.
Note the the missing joint material. Also note the minor weep from
the repaired crack in the bottom of the left training wall.**

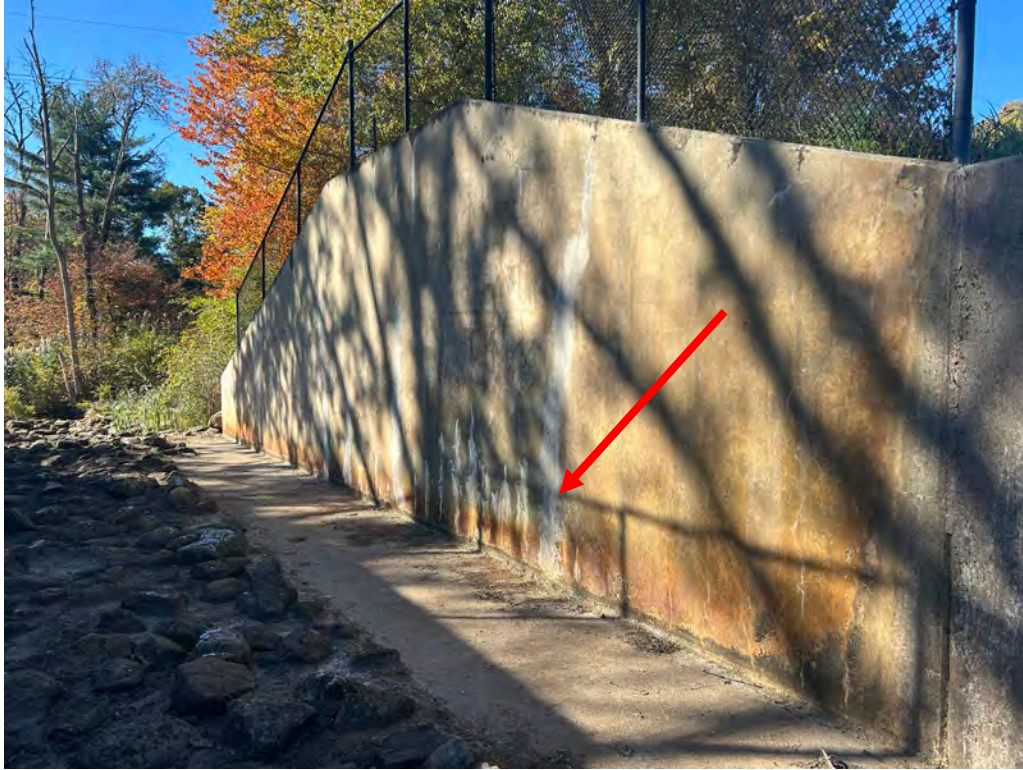
During previous inspections, several vertical cracks with efflorescence were observed at various spacing along both training walls. One 5-foot long (measured this inspection) horizontal crack and minor spall with efflorescence was previously observed at the downstream end of the right training wall. A horizontal crack was previously observed in the top of the right training wall extending from the downstream end of the wall to the fence post. The vertical cracks in the training walls and the horizontal cracks in the downstream end of the right wall were repaired in November 2023. The repairs appeared intact. Similar to previous inspections, a few minor horizontal cracks with efflorescence were observed at the contacts between the training walls and spillway. Efflorescence appeared more prevalent on the right training wall.

**Photo No. 25: Right side spillway training wall looking downstream.
Note the efflorescence and repaired cracks in the wall.**

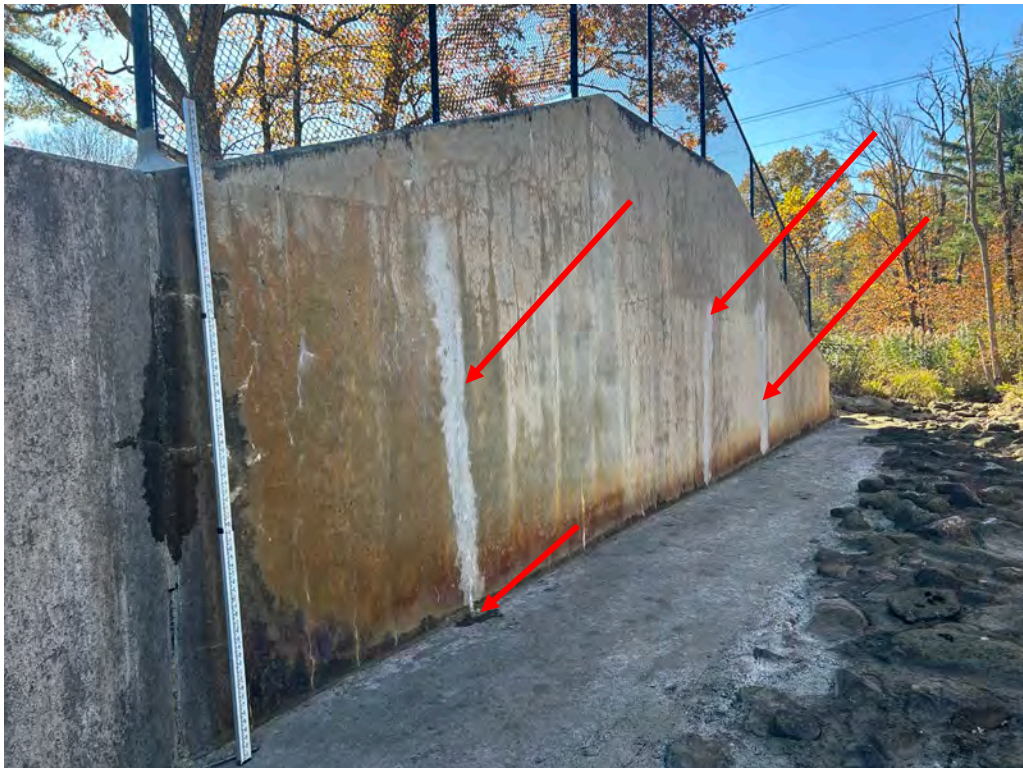
**Photo No. 26: Left side spillway training wall looking downstream.
Note the efflorescence and repaired cracks in the wall. Also note the
minor weep from the repaired crack in the bottom of the left training wall.**
