2024 REGULAR INSPECTION REPORT

SENECA LAKE DAM (NJDEP File No. 22-183)

Sparta Township
Sussex County, New Jersey

GZA GeoEnvironmental, Inc.

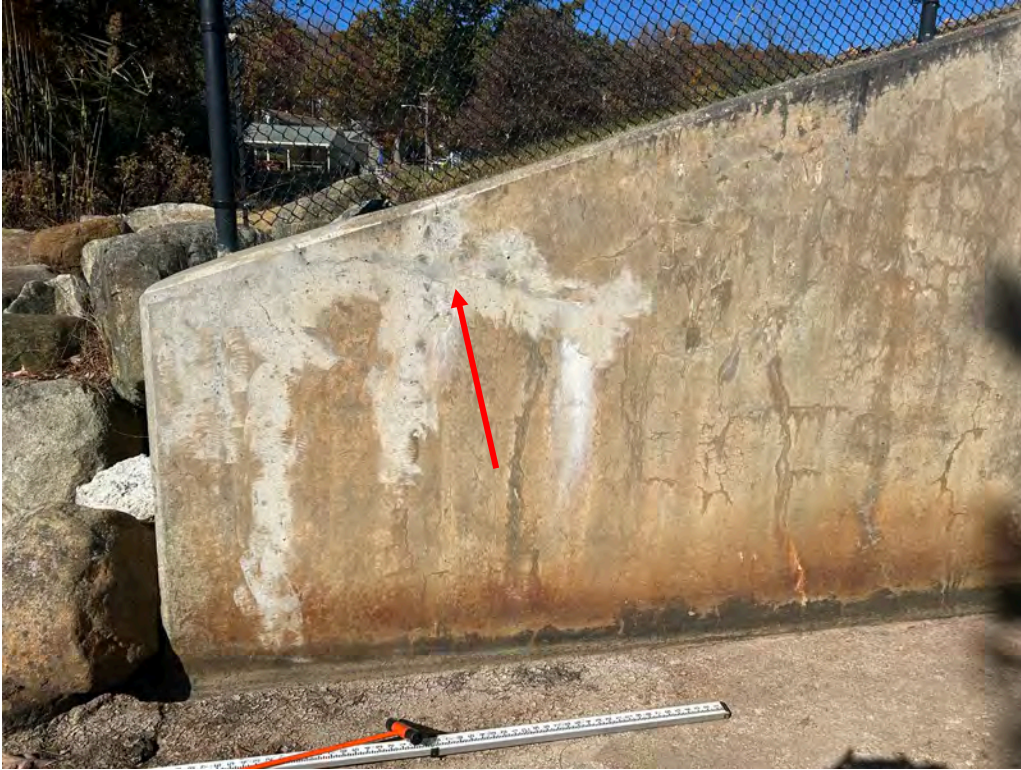
**Photo No. 27: Downstream end of the right spillway training wall.
Note that the 5-foot long horizontal crack was repaired.**

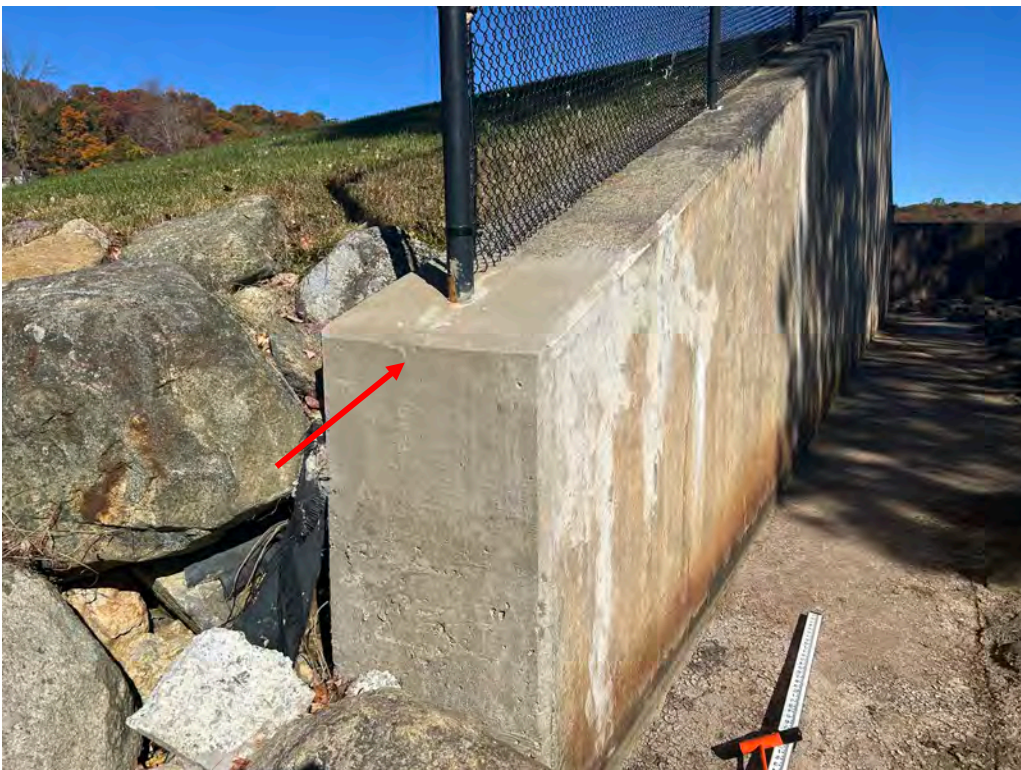
**Photo No. 28: Top of the right training wall at the downstream end of the wall
Note that the crack was repaired.**

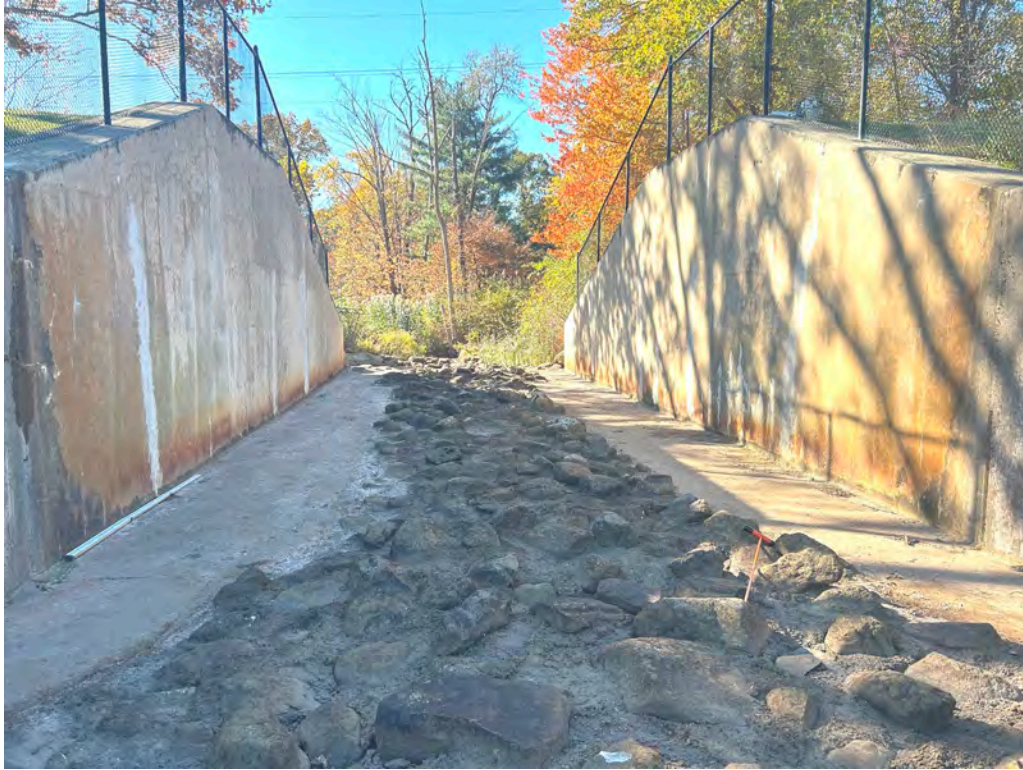
Photo No. 29: Grouted riprap discharge channel looking downstream.

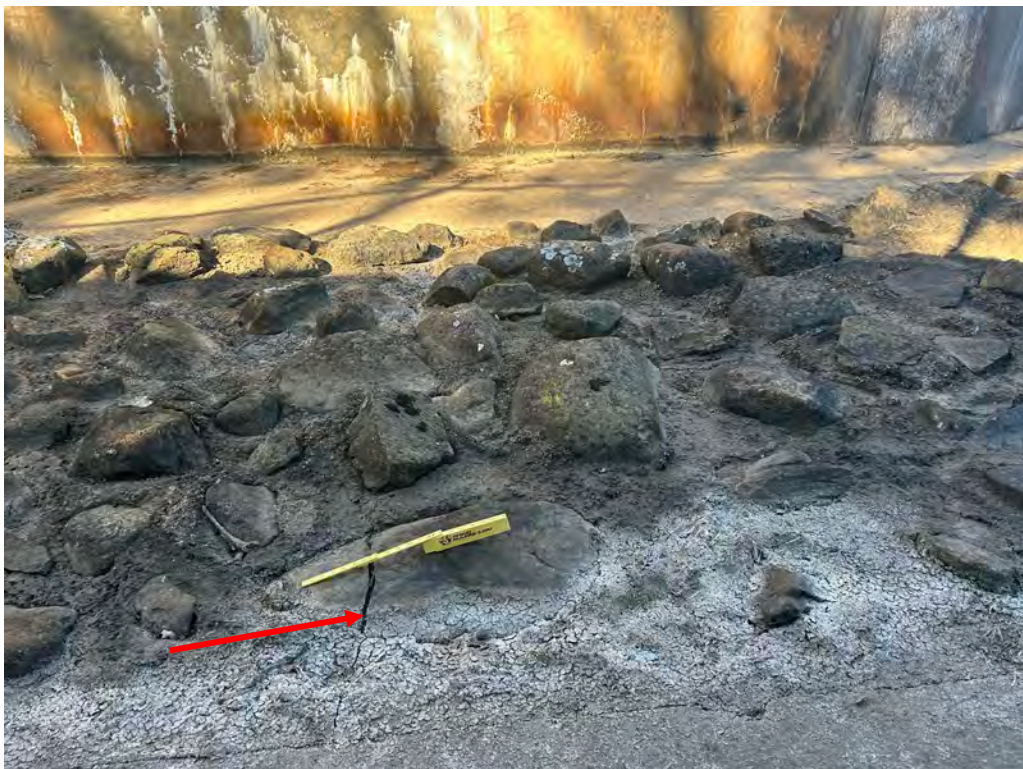
Grouted riprap appeared intact and in good condition with some missing stones near the downstream end of the training walls. No voids were observed in the grouted riprap. A transverse crack was observed in the grouted riprap in between the training walls. The crack measured about 0.5 inches wide (maximum) and extended from the left edge to about halfway across the grouted riprap portion of the channel. The crack should be repaired.

Photo No. 30: Crack across the grouted riprap discharge channel looking toward the right training wall.

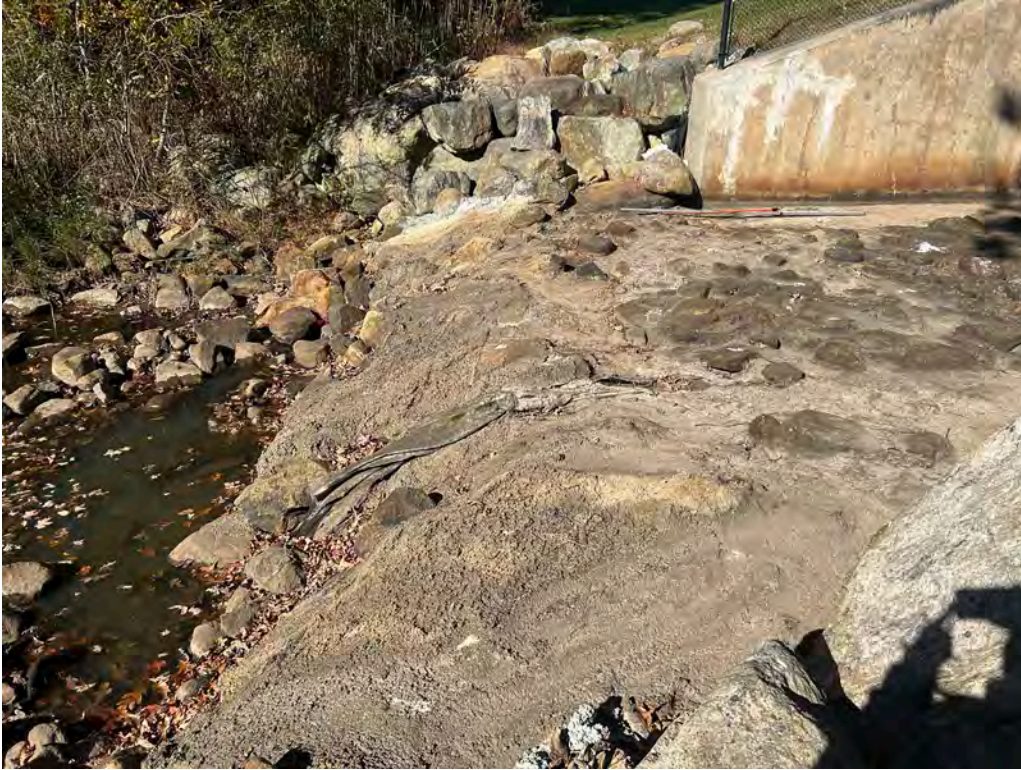
Signs of Movement: During previous inspections, an area of the riprap apron was displaced, possibly a result of the steep transition from the discharge channel to the apron. The area was repaired by extending the grouted riprap discharge channel several feet downstream and sloping the grouted riprap to create a shallower transition to the loose riprap apron. The grouted riprap extension appeared stable.

Photo No. 31: Downstream riprap apron looking right. Note the extension of the grouted riprap onto the apron since the 2022 inspection.

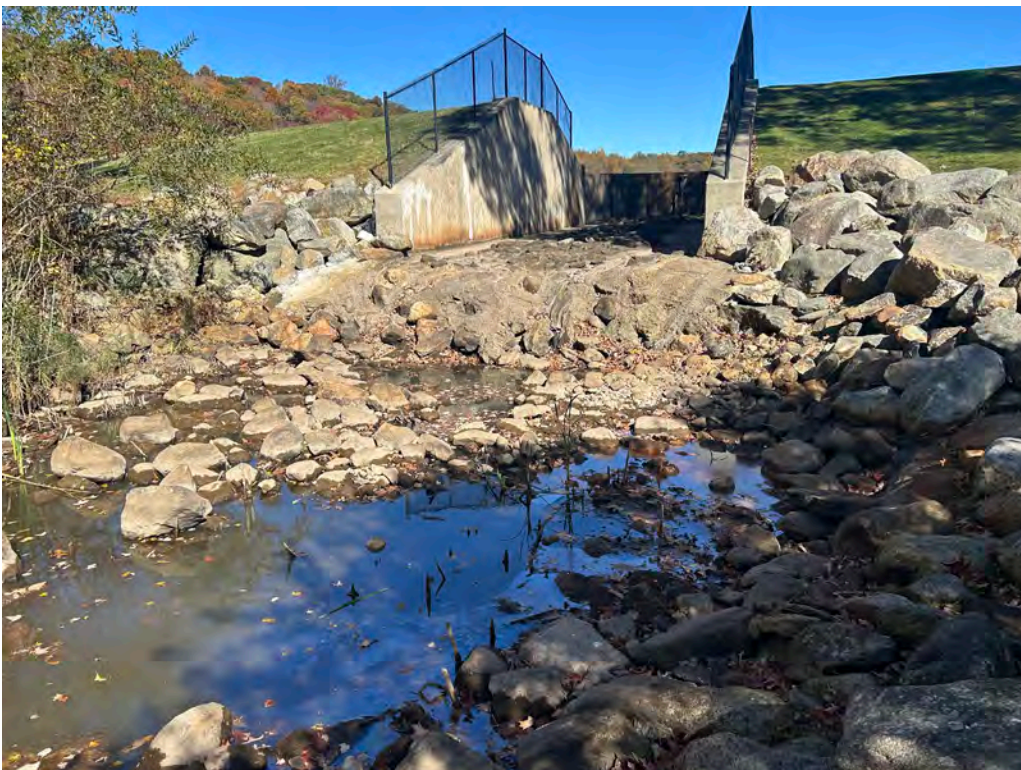
Photo No. 32: Downstream riprap apron looking upstream. Note the extension of the grouted riprap onto the apron since the 2022 inspection.

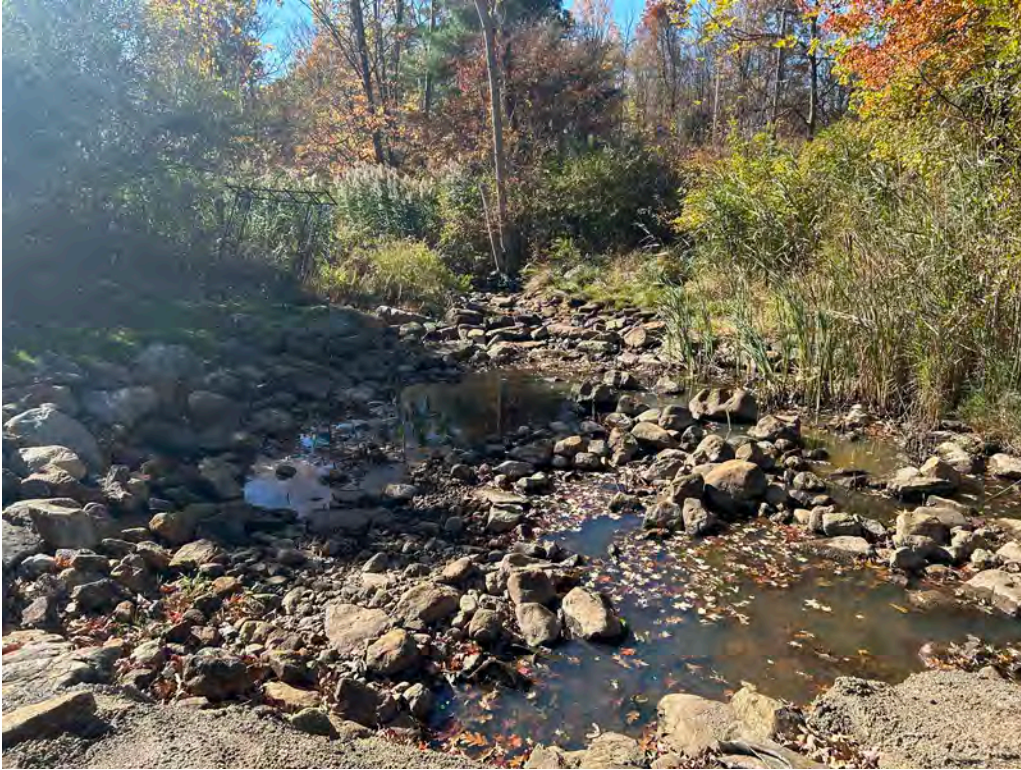
Vegetation (trees, bushes): Stand of thick cattails was removed from the plunge pool since the 2022 inspection. Several large trees and grassy vegetation were observed along the sides of the channel.

Photo No. 33: Looking downstream at the plunge pool and exit channel toward the Tomahawk Trail bridge.

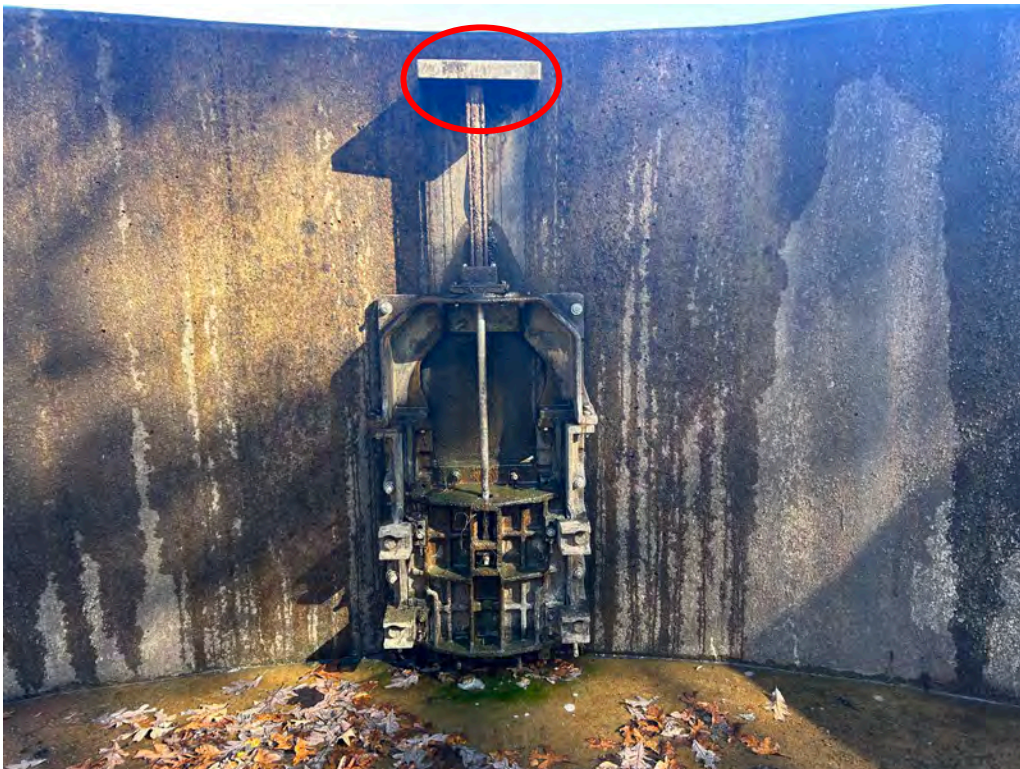
- Description:** 18-inch square sluice gate mounted on the downstream face of spillway. Sluice gate is controlled by a remote hydraulic operator that is located within an enclosure on the crest of the dam immediately right of the spillway training wall.
- Condition:** The Owner indicated that the sluice gate was operable, and no problems were encountered with the hydraulic operator during past operations. The enclosure was opened during this inspection, and some rust was observed on the hydraulic cylinder encasement.
- Trash Rack:** None

Photo No. 34: Closeup of the low level outlet sluice gate. Note the deflection cover over the hydraulic operating cylinder.

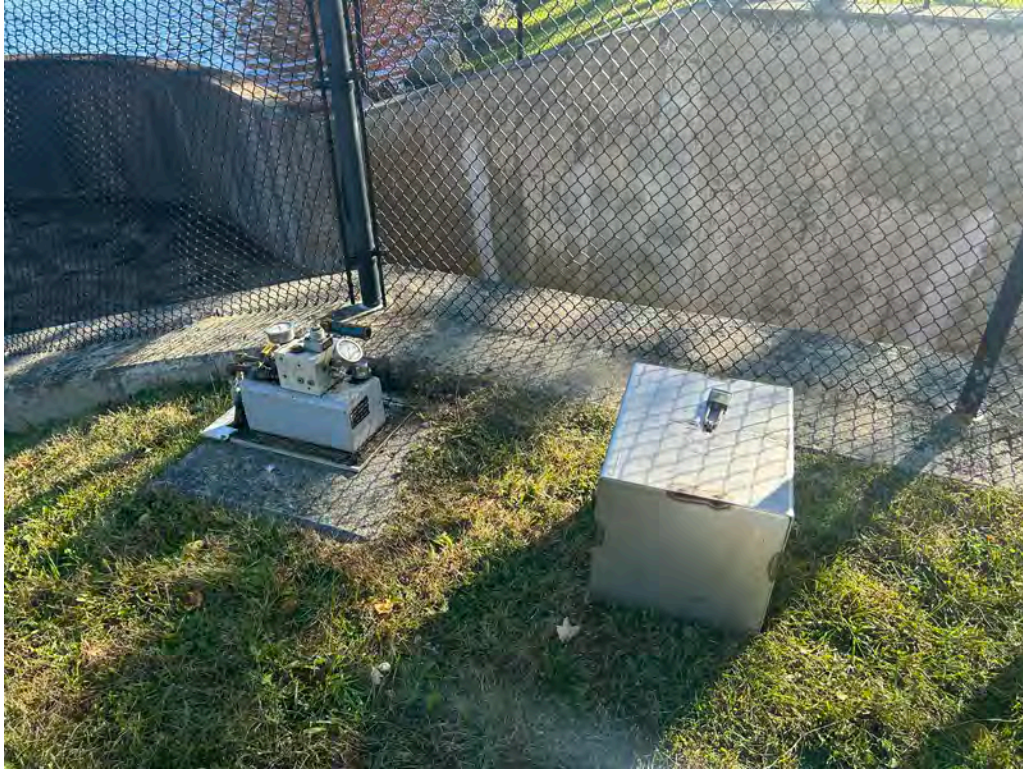
Miscellaneous: The hydraulic operator enclosure is located on the right-side dam embankment crest adjacent to the right spillway training wall. A steel plate covers a missing section of the enclosure's concrete footing. The lock on the operator enclosure was in place.

Photo No. 35: Hydraulic operator and enclosure for the low level outlet sluice gate.

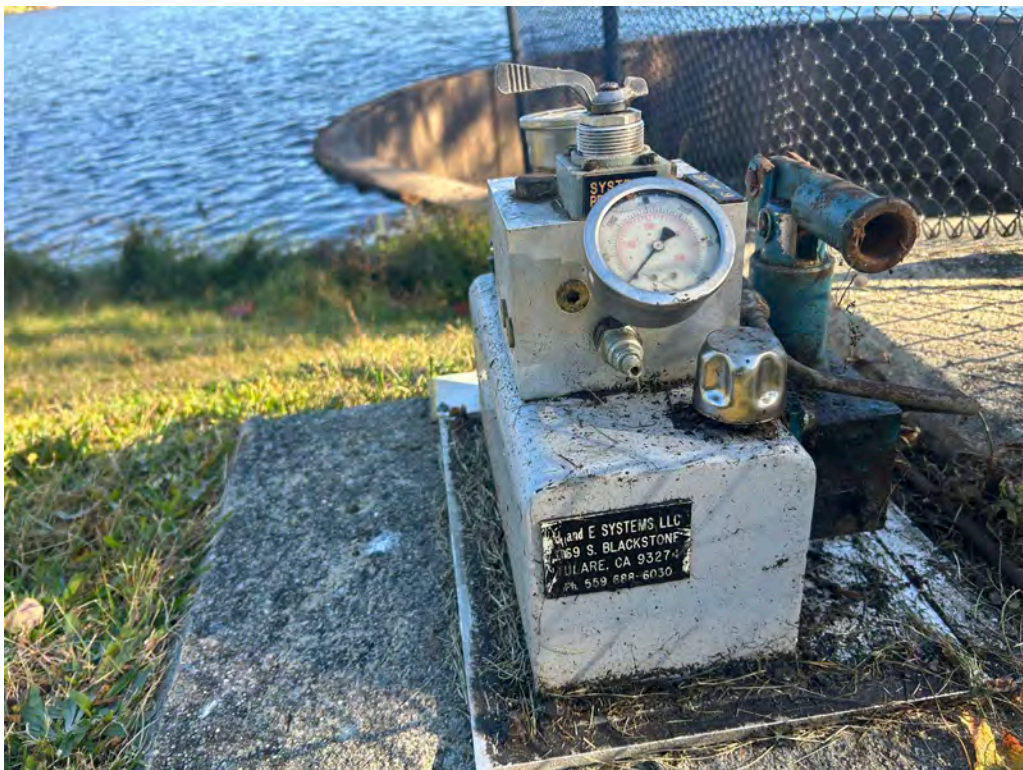
Photo No. 36: Closeup of the hydraulic operator for the low level outlet sluice gate.
